RESIDENTIAL INSPECTION

04/11/2025

Joshua Shellenberger

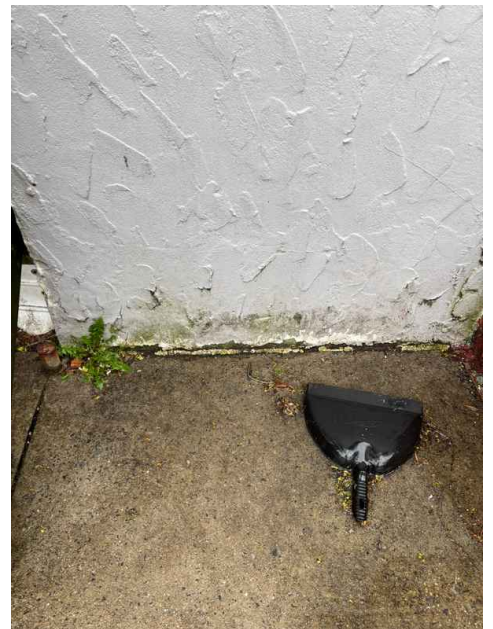
3.2.4 Driveway and Walkway Condition

There were gaps between concrete surfaces and the structure. Gaps can allow water penetration which can damage the foundation during freeze cycles. Recommend having a qualified contractor repair and/or seal as needed.

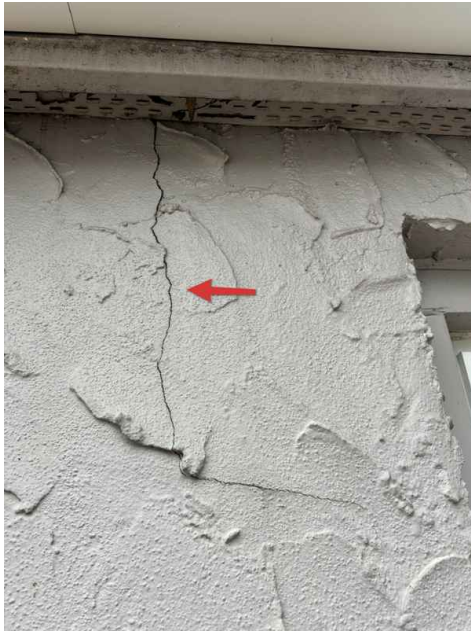
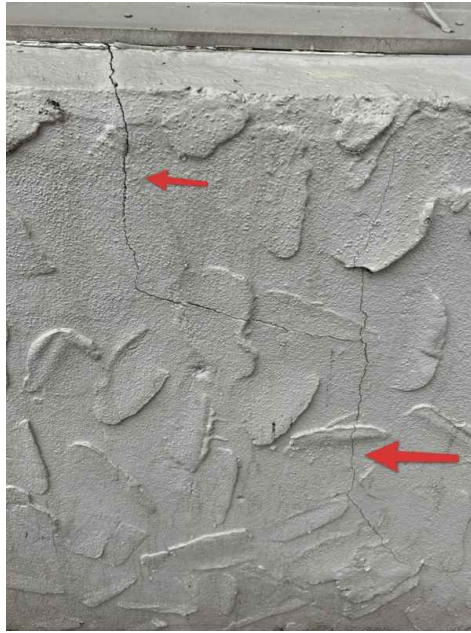
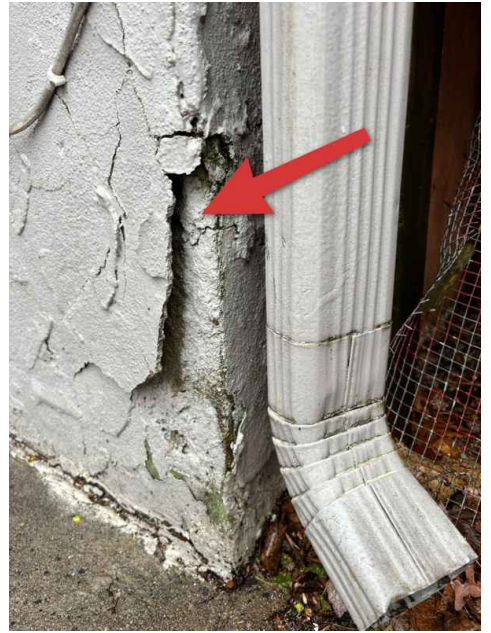
***HARDCOAT - DAMAGE/STAINING**

Damage/staining was noted in one or more areas of the hardcoat finish. Any damage to the surface can create a pathway for moisture which can lead to structural damage, mold etc. Staining on the surface below drip edges may also indicate that water has been permeating into the surface. Recommend having a qualified hardcoat inspector further evaluate and repair as needed.

Recommendation
Contact a qualified siding specialist.

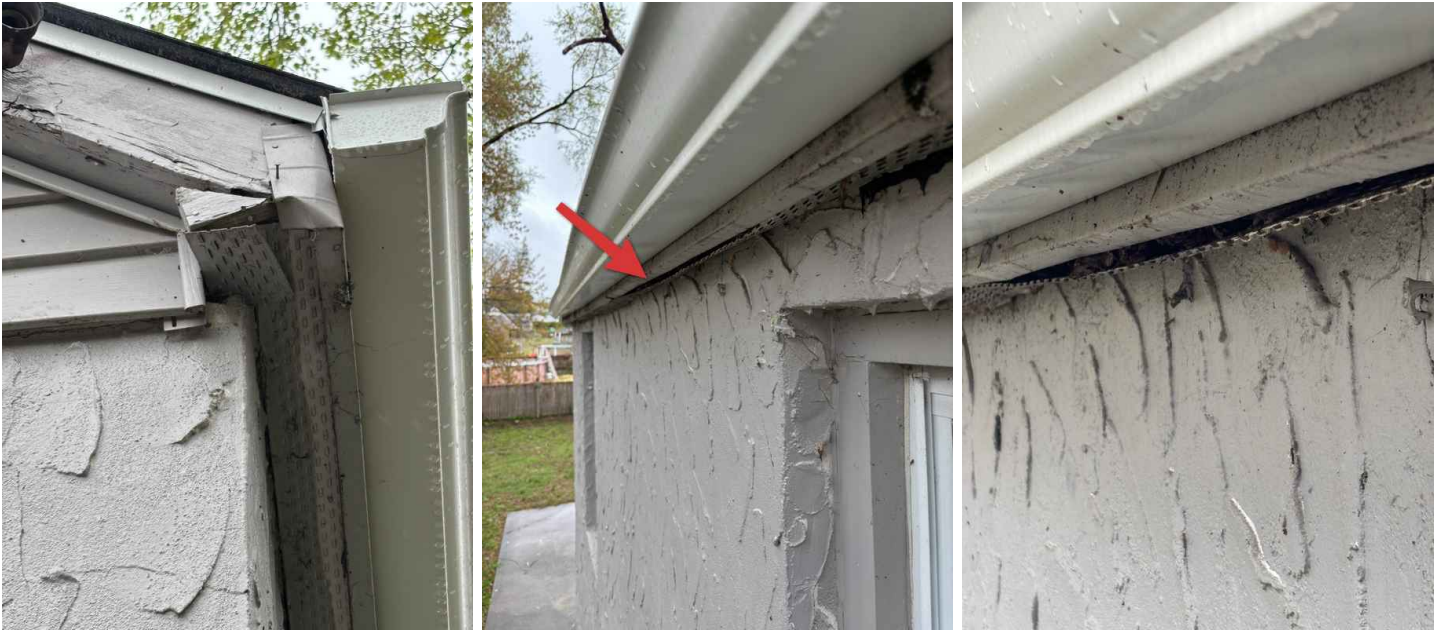
There were one or more areas of soffit that were loose, damaged, missing, and/or substandard. This can allow insects and vermin easy access into the soffit areas. Recommend having a qualified contractor repair or replace as needed.

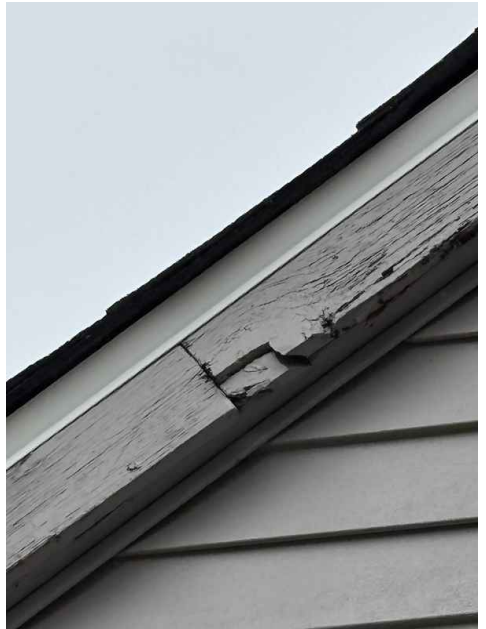
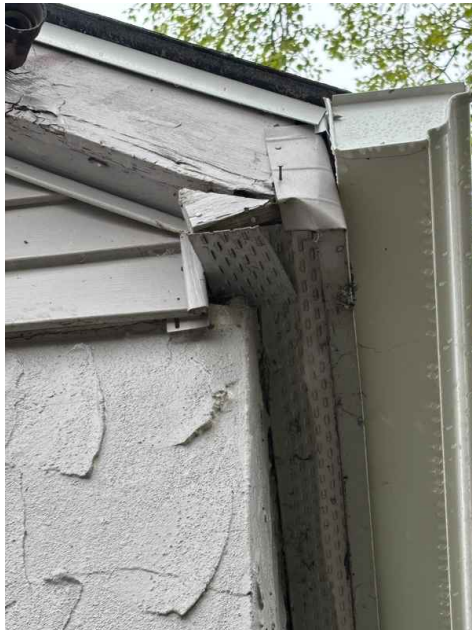
5.5.2 Eaves/Overhangs/Fascia

***WOOD - DAMAGE**

Some degree of damage, water damage, including but not limited to rotted wood was noted on the overhangs, soffits and/or fascia in areas. Damaged, displaced eaves, fascia, leaves access for wildlife etc. to enter the walls, attic. Recommend having a qualified contractor evaluate and repair or replace as needed.

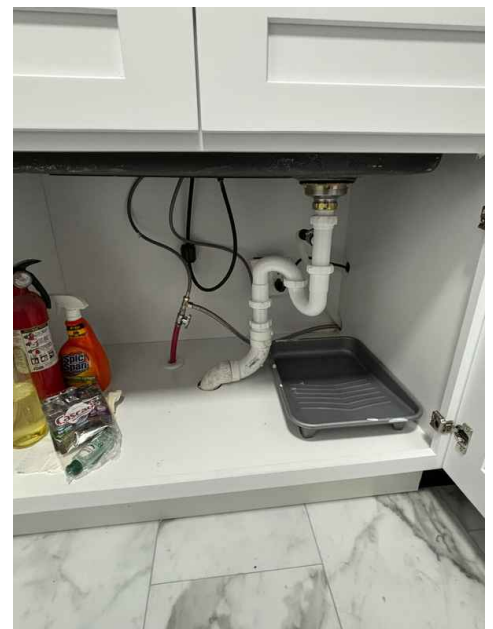
The kitchen drain contained one or more "S" traps. "S" traps are not allowed by current standards due to the potential of this design to siphon the water "seal" out of the trap, allowing sewer gases to enter the home. Recommend having a licensed plumber repair as needed.

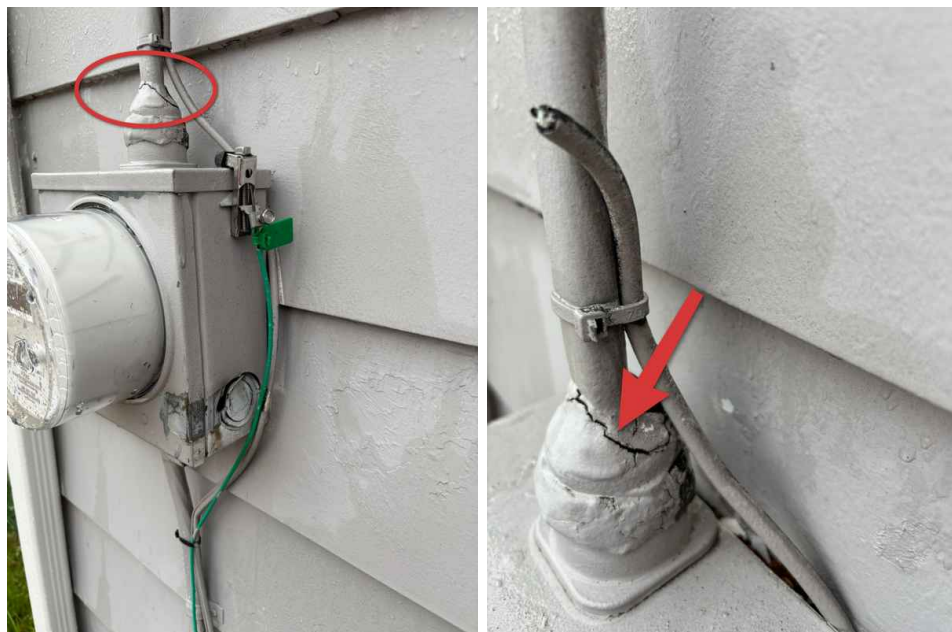
The seal around the service entrance cable was missing or deteriorated. This can allow water to enter the structure and the service equipment panels. Recommend having a licensed electrician reseal these areas.

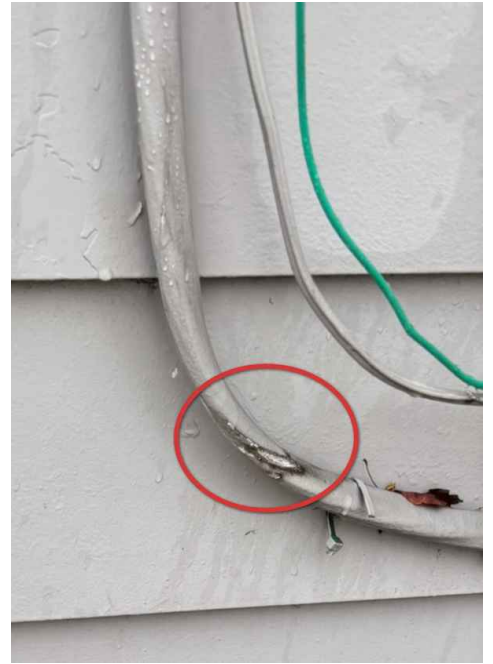
13.2.2 Service Entrance

*SEC - MISSING, DAMAGED, SUBSTANDARD INSULATION

The insulation on the service entrance cable was deteriorated. This can expose the conductors to the elements and pose a shock hazard. Recommend having a licensed electrician replace the service entrance cable.

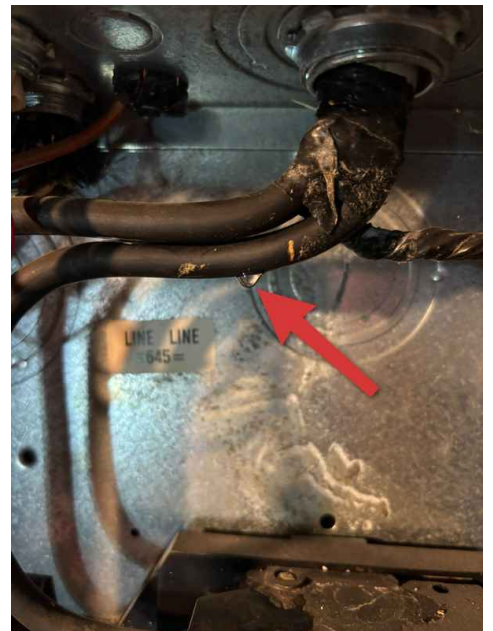
*Water was actively leaking into the service panel.

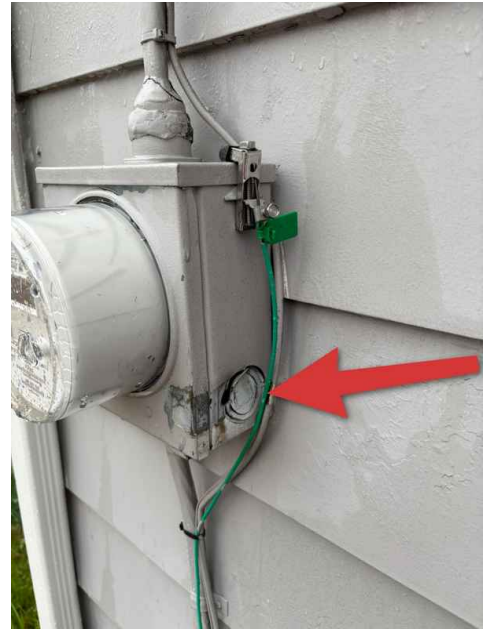
13.5.2 Service Equipment/Electrical Panel

***KNOCKOUTS MISSING**

One or more knockouts were missing from the electrical meter. Missing knockouts can allow mice and insects to enter the panel and nest., It can create a shock hazard for people inadvertently sticking fingers into the panel. Filler plugs in conjunction with the cover being properly installed also help to contain fire in the case of an overload or other malfunction. Recommend having a licensed electrician install caps as needed.

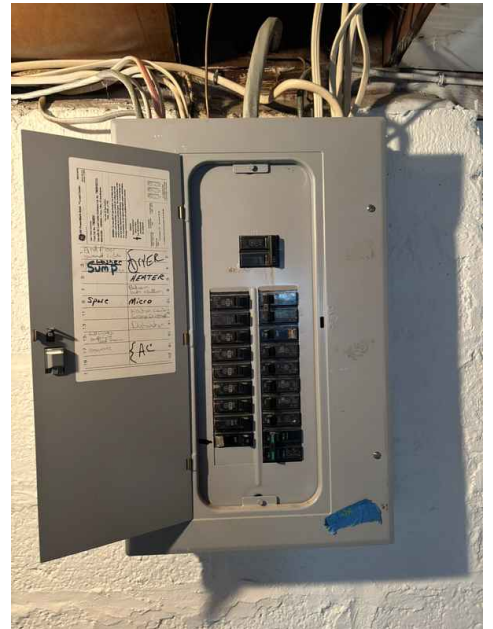
13.5.3 Service Equipment/Electrical Panel

***LEGEND - INCOMPLETE, INCORRECT, OR MISSING**

The legend was missing, incomplete, or substandard. This is dangerous in the case of an emergency when power needs to be shut down. Recommend correcting the legend so it's accurate, complete and legible. Evaluation by a licensed electrician may be necessary.

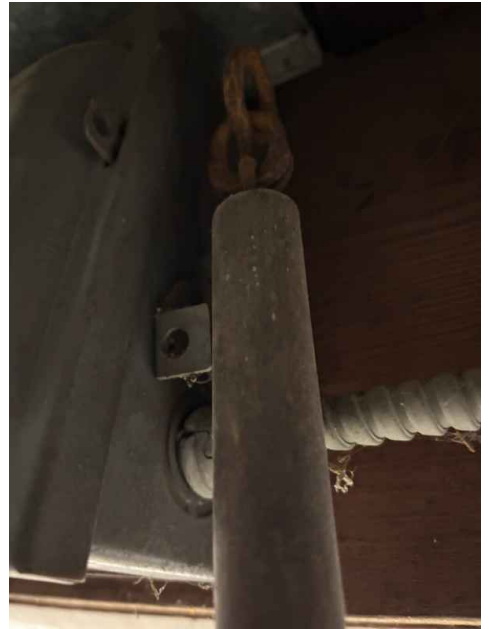
13.7.1 Sub Panel

SUBPANEL - MULTIPLE DEFECTS

The subpanel was an old Wadsworth panel which is outdated. The subpanel utilized glass screw base fuses, these are also an outdated technology and can be dangerous because oversized fuses may be installed. The inspector did not have full visual access and could not determine if grounding and bonding were correct. Recommend having a licensed electrician evaluate and repair/replace as needed.

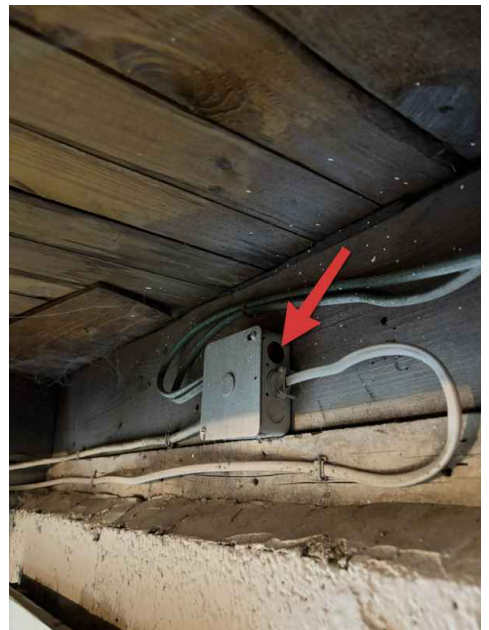
There were one or more junction boxes missing approved connectors, bushings or caps. If wires are run through these openings it leaves the wire exposed to the sharp metal edges of the box, without wires it leaves an opening that someone could put a finger in and get shocked. These are potentially dangerous conditions. Recommend a licensed electrician repair as needed.

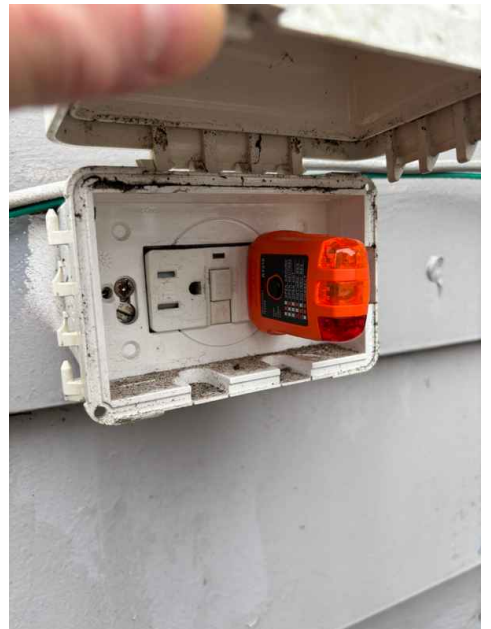
13.10.2 GFCI Protection

***GFCI - WOULD NOT RESET**

One or more GFCI receptacles were tripped testing for proper operation or were tripped prior to the inspector testing them and would not reset, leaving it inoperable. This is indicative of a defective GFCI outlet or that a ground fault exists on that circuit. Recommend having a licensed electrician evaluate and repair/replace as needed.

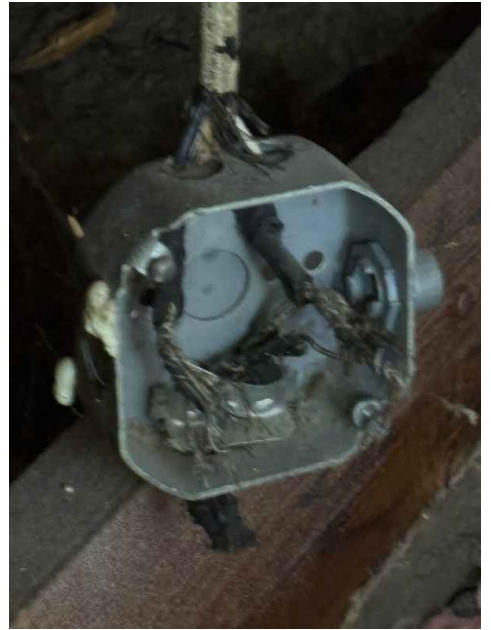
13.11.1 Receptacles

***COVERS**

There were one or more cover plates for switches, receptacles, lights or junction boxes that were loose, missing, broken, missing screws, wrong cover for the application or substandard. These plates are intended to contain fire and prevent electric shock from occurring due to exposed wires and terminals, and to seal out the weather when applicable. Recommend having a licensed electrician install cover plates where necessary.
