RESIDENTIAL INSPECTION

04/11/2025

Joshua Shellenberger

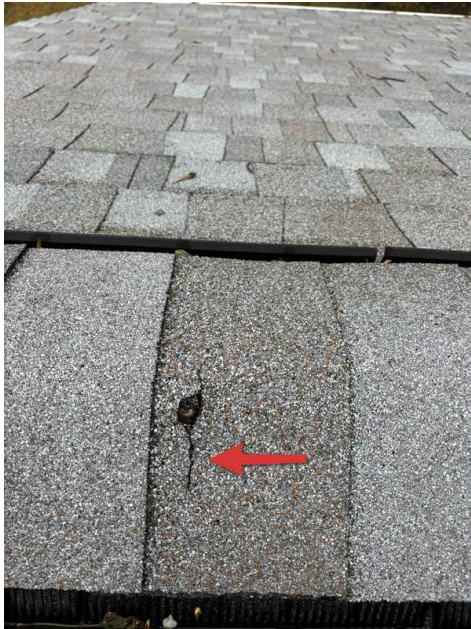
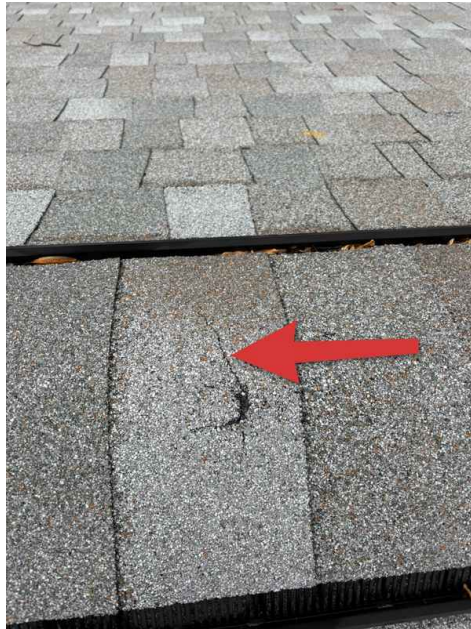
2.2.2 Shingles

*NAIL POPS

Recommendation

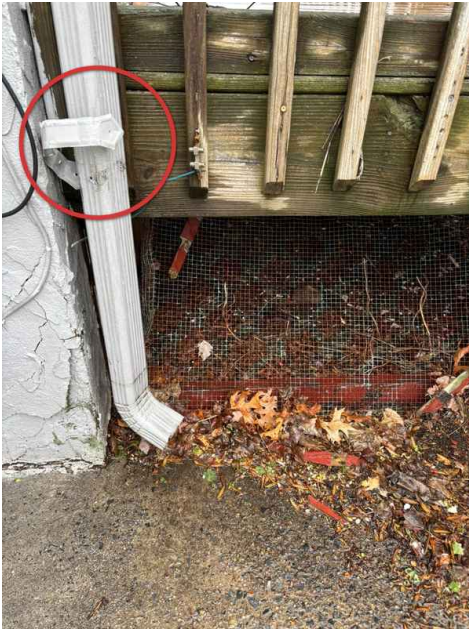
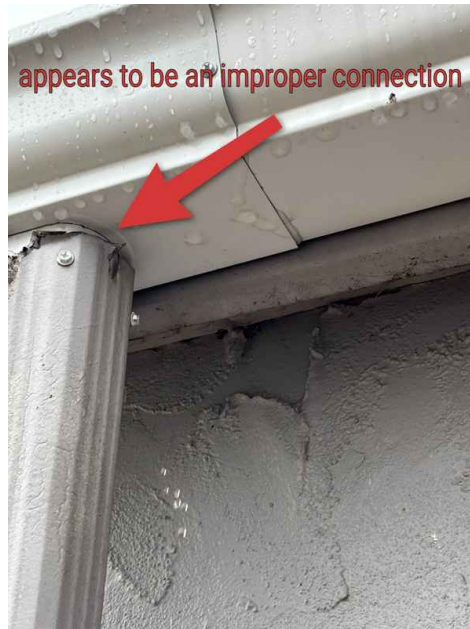
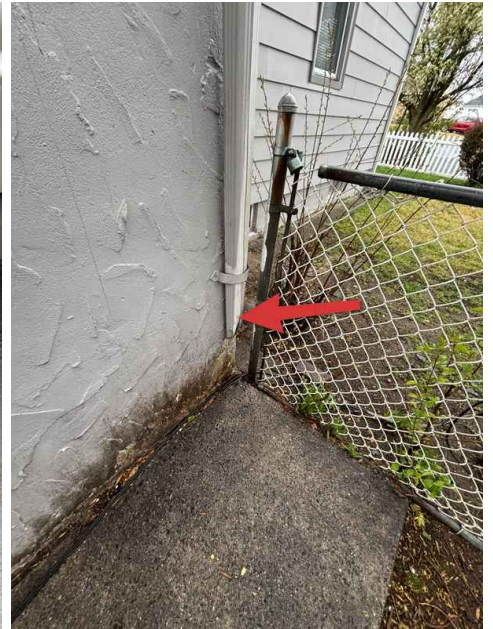
2.6.3 Gutters / Downspouts

***GUTTER(S) - LEAVES/DEBRIS**

Recommendation

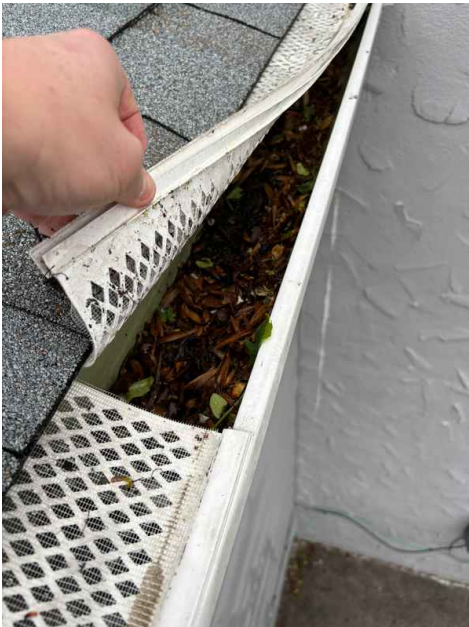
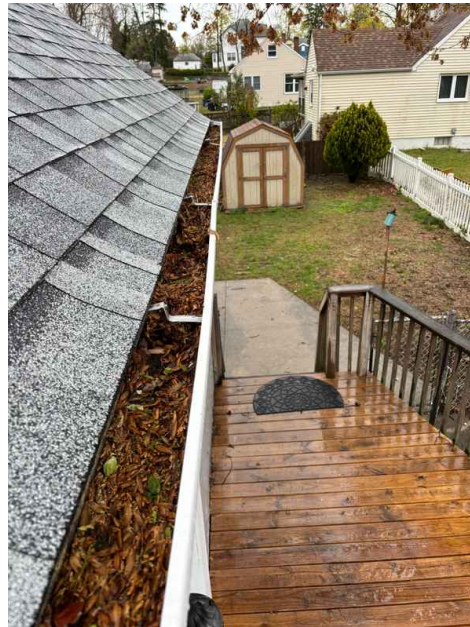
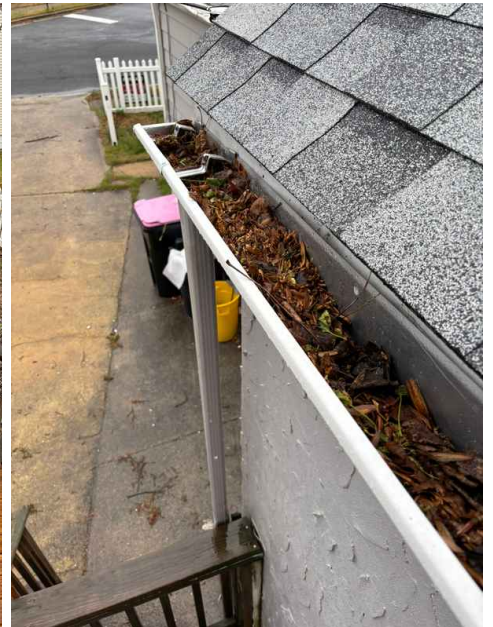
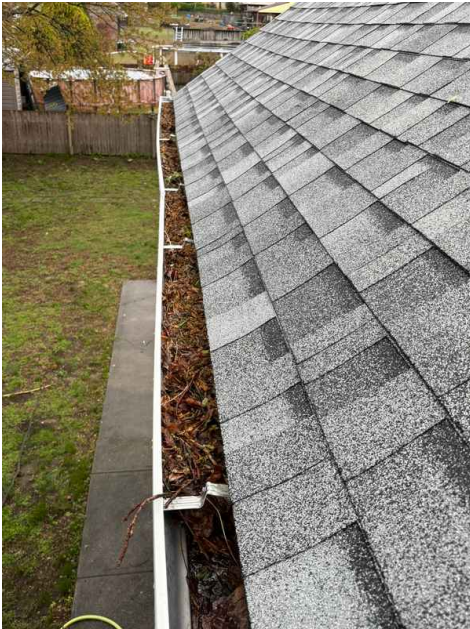
2.6.4 Gutters / Downspouts

***GUTTERS LOOSE**

Recommendation

Contact a qualified professional.

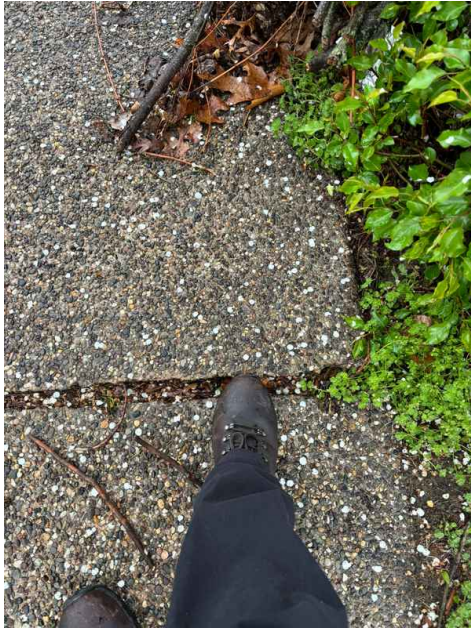
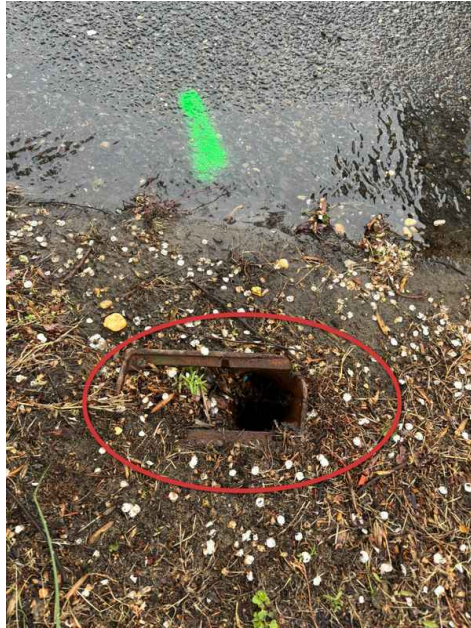
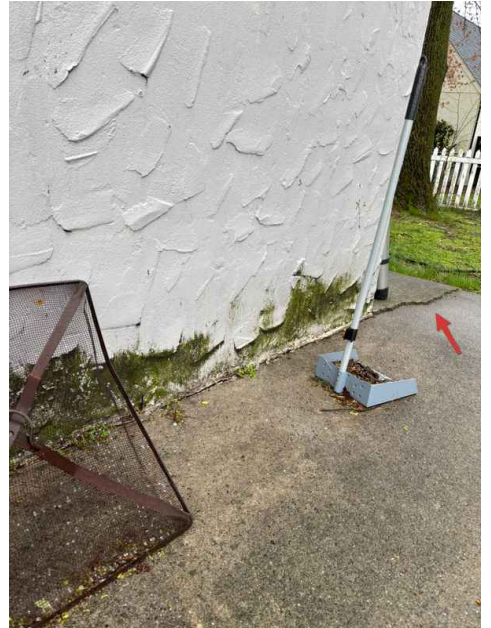
3.2.2 Driveway and Walkway Condition

***AGE APPROPRIATE DETERIORATION DRIVEWAY/WALKWAYS/PATIOS**

Recommendation

Contact a qualified professional.

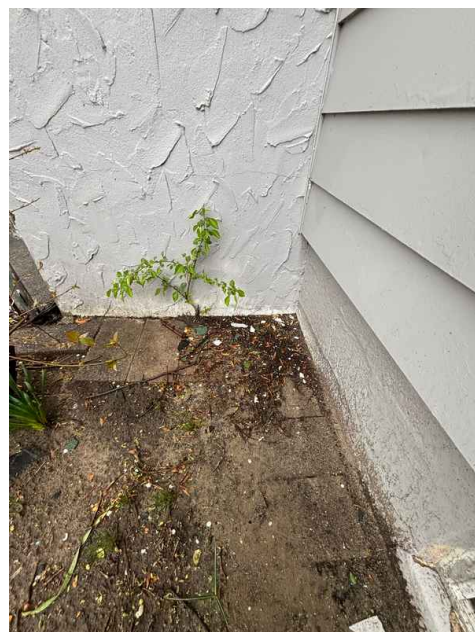
3.4.2 Vegetation Observations

***TREE - CLOSE TO FOUNDATION**

One or more trees and/or their roots were in close proximity to the foundation of the home. Tree roots can compromise the foundation depending on the size and species of the tree. Recommend consulting an arborist for additional information. In some cases a structural engineer may be needed to be consulted as well.

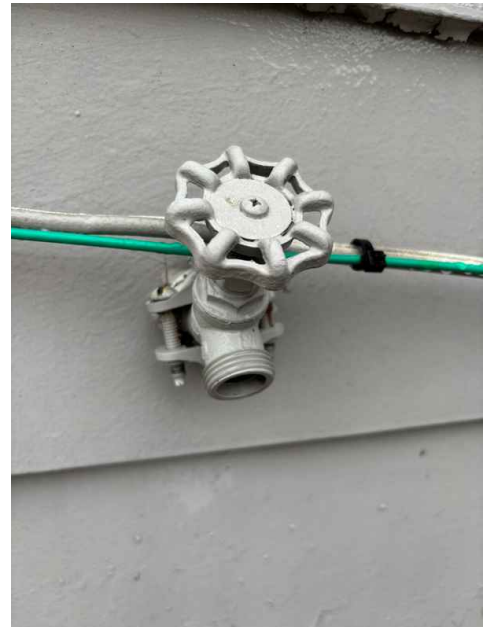
3.7.2 Exterior Spigots

***ANTI-SIPHON**

Recommendation

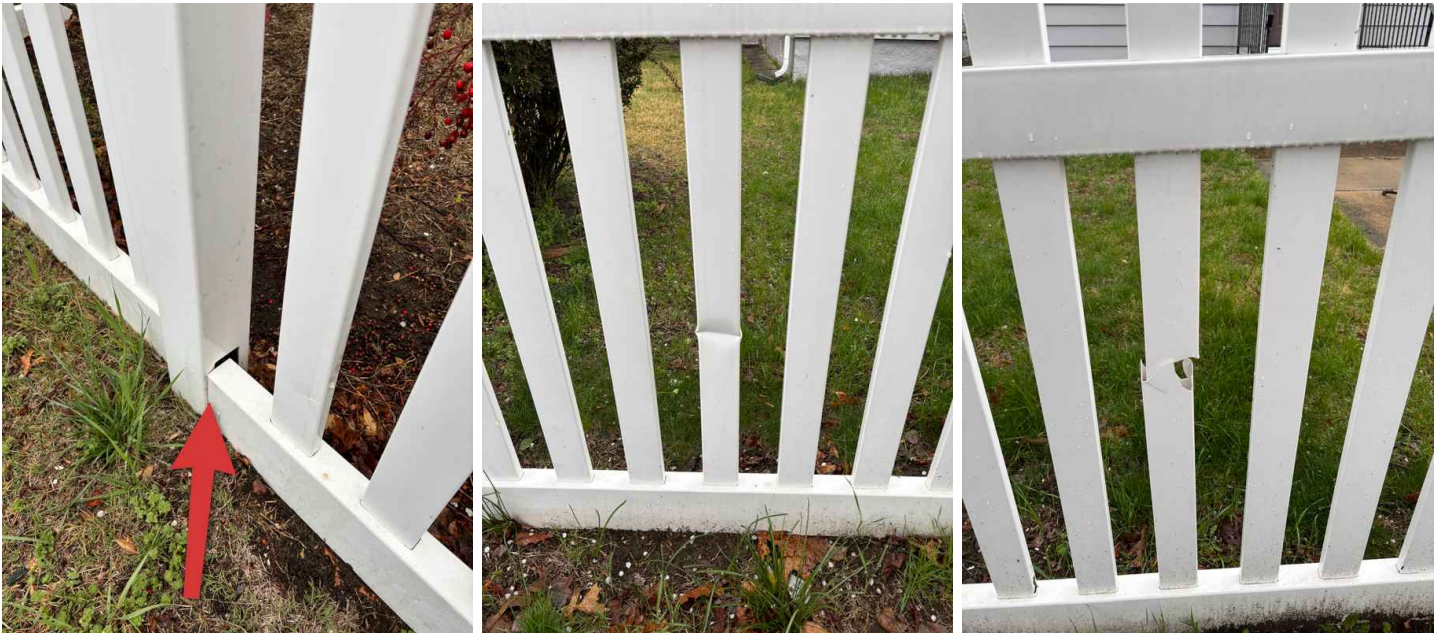
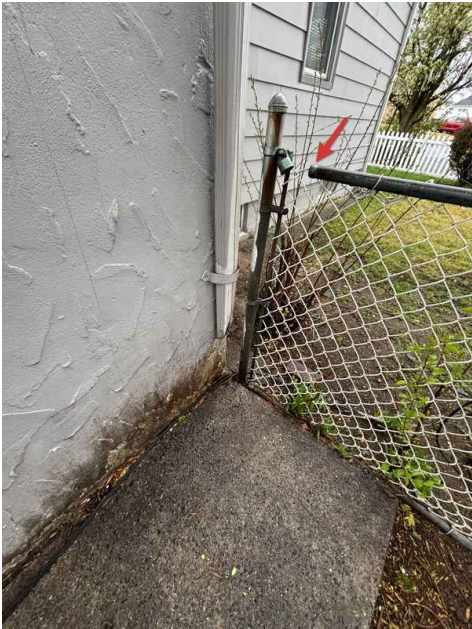
***FENCES LOOSE/DAMAGED/MISSING/SUBSTANDARD**

Although the inspector is not inspecting fences any obvious defects and/or potentially dangerous conditions are disclosed, any comments made or pictures are a courtesy only and should not be construed as a complete inspection of these components. There were loose/damaged/missing or substandard sections of fence. This results in exposed fasteners such as nails and screws that may pose a safety concern. Recommend having a qualified fence company repair/replace the fences as needed.

Contact a qualified fencing contractor

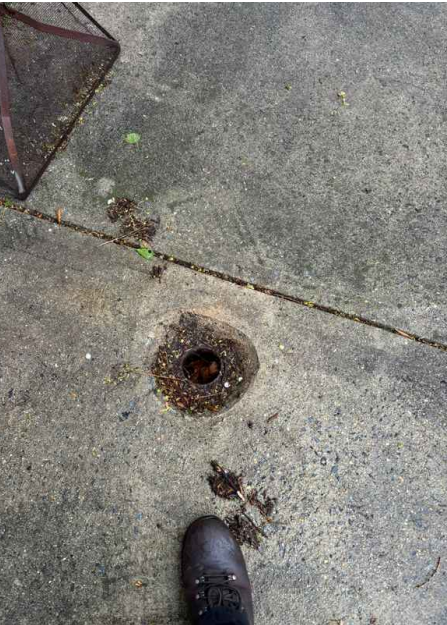
General Info: *Unknown Pipe

FYI - There was a pipe exiting the structure at the referenced area(s), and their purpose could not be determined. I recommend consulting with the sellers as to the purpose of the pipe, and if they have no information, recommending having a qualified contractor perform an evaluation, as needed.

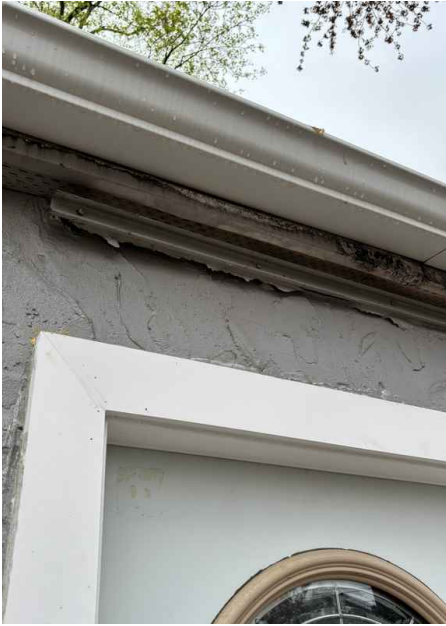
General Info: Bracket

FYI - There appears to be one or more abandoned awning brackets. Although not a defect, the client may wish to have the bracket(s) removed for aesthetic reasons.

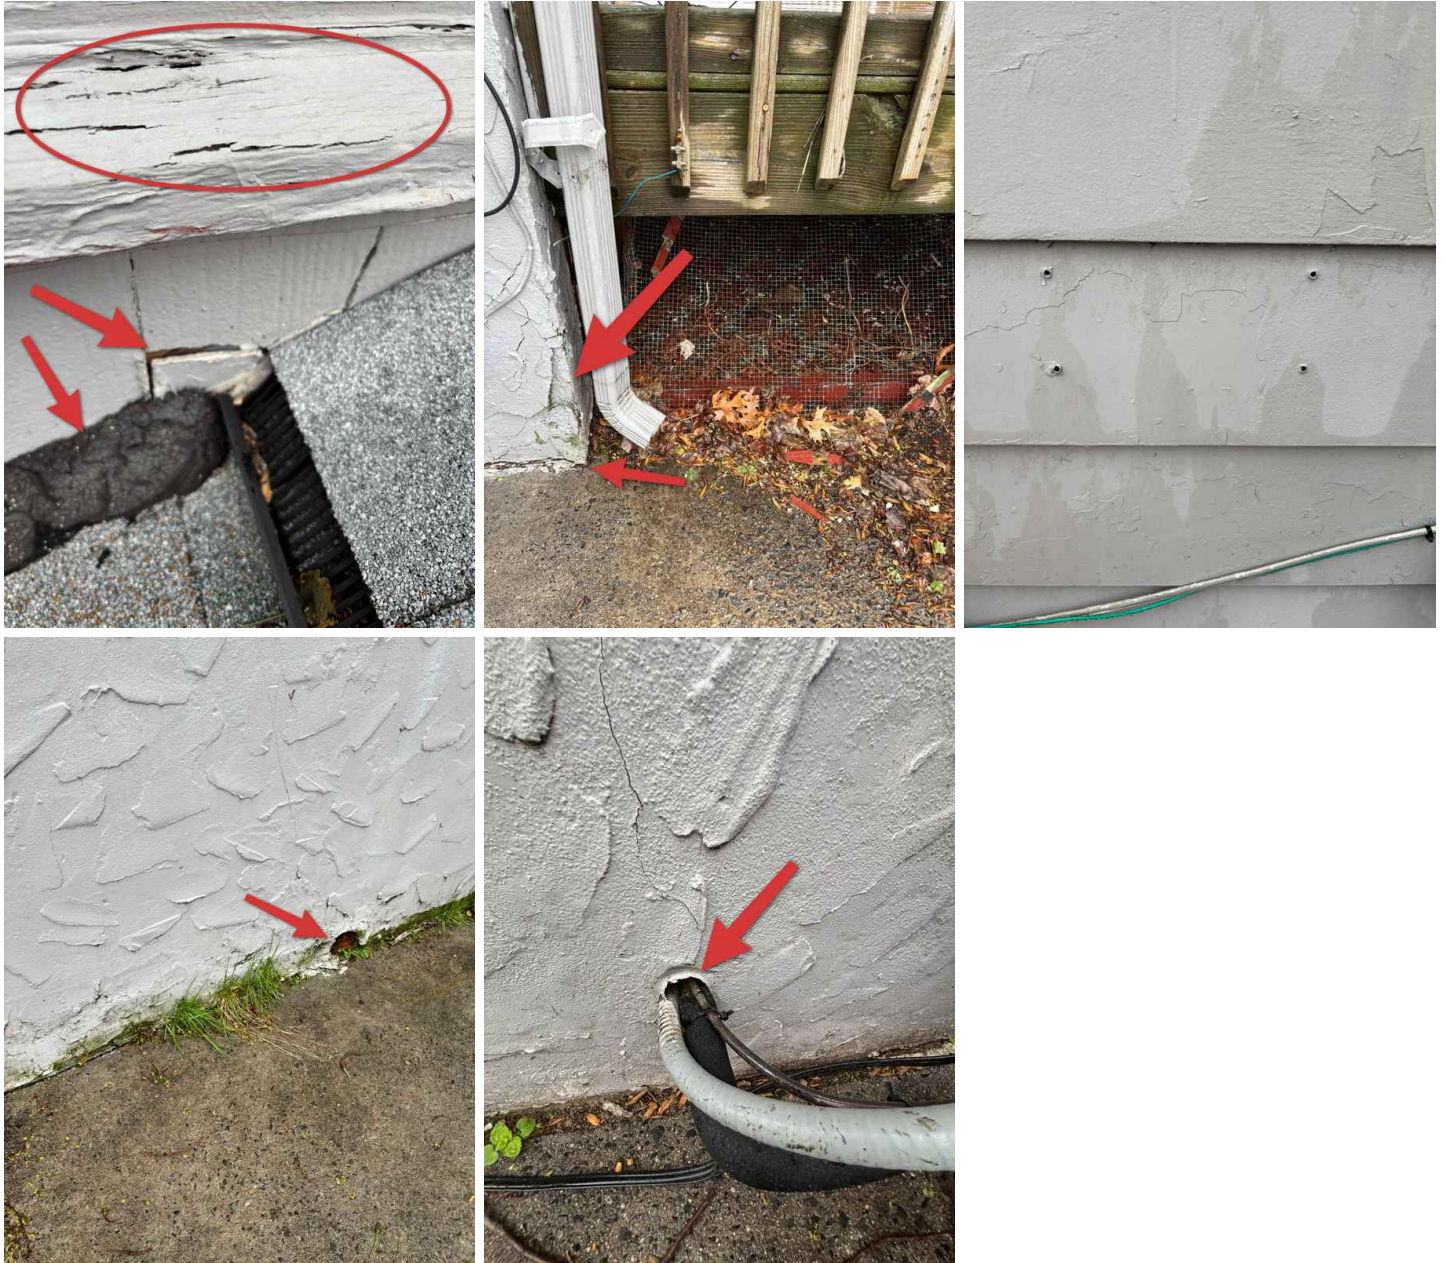
***SIDING/TRIM DEFECTS**

Defects in siding, cladding and/or trim were noted. This may include discoloration, holes, gaps, deterioration, rot, loose, missing, warped, damaged, substandard, water permeation, etc. Gaps can cause damage to the substructure, such as, but not limited to: allowing pests to nest behind siding, water permeation to cause rot, mold or fungal growth. Recommend having a qualified contractor evaluate the exterior finishes and repair/replace/seal as needed.

NOTE: There was deteriorated wood, damaged siding, moss/algae growth on exterior wall(s).

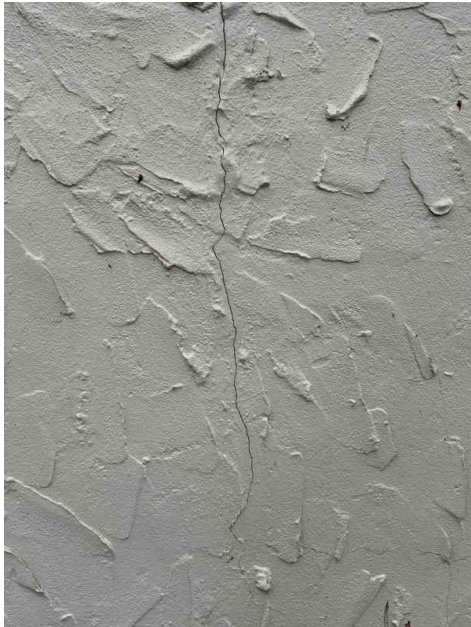
***HARDCOAT - DAMAGE/STAINING**

Damage/staining was noted in one or more areas of the hardcoat finish. Any damage to the surface can create a pathway for moisture which can lead to structural damage, mold etc. Staining on the surface below drip edges may also indicate that water has been permeating into the surface. Recommend having a qualified hardcoat inspector further evaluate and repair as needed.

Recommendation
Contact a qualified siding specialist.

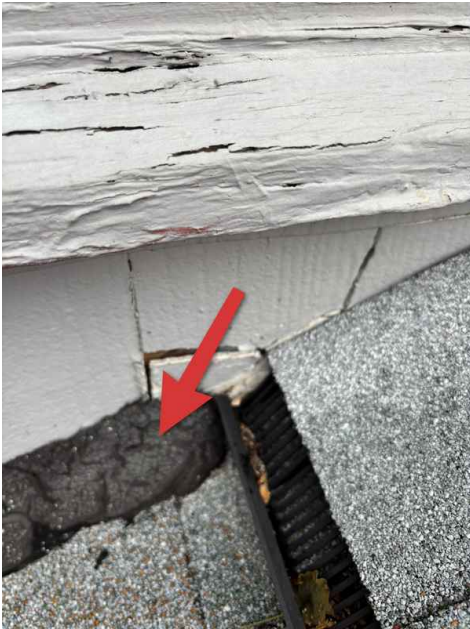
5.4.1 Wall Flashings

***MISSING FLASHING**

There were areas that were missing flashings. These areas can allow for water infiltration behind the cladding, causing hidden damage to the substructure, moisture can lead to mold growth. Recommend having a qualified contractor evaluate and repair as needed.

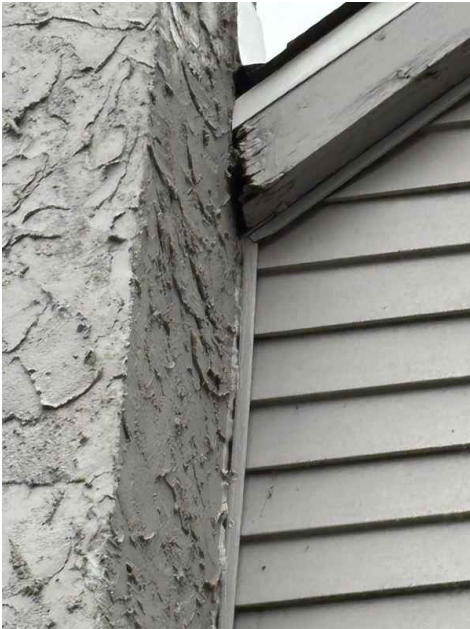
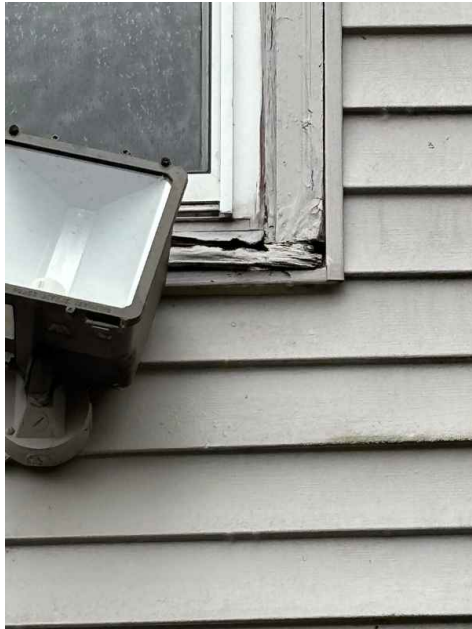
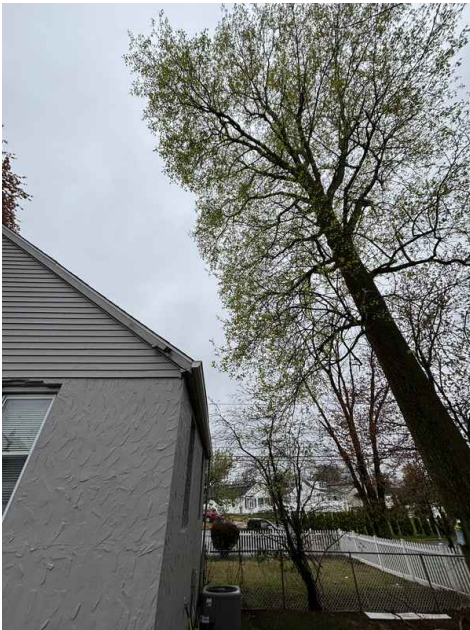
5.5.1 Eaves/Overhangs/Fascia

***SOFFIT - LOOSE/DAMAGED/MISSING/SUBSTANDARD**

There were one or more areas of soffit that were loose, damaged, missing, and/or substandard. This can allow insects and vermin easy access into the soffit areas. Recommend having a qualified contractor repair or replace as needed.

***WOOD - DAMAGE**

Some degree of damage, water damage, including but not limited to rotted wood was noted on the overhangs, soffits and/or fascia in areas. Damaged, displaced eaves, fascia, leaves access for wildlife etc. to enter the walls, attic. Recommend having a qualified contractor evaluate and repair or replace as needed.

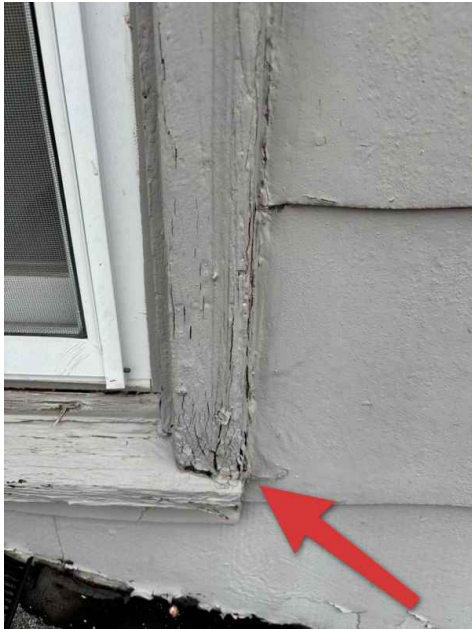
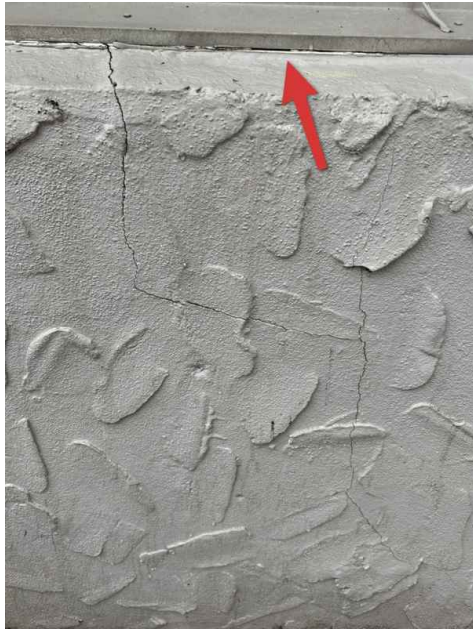
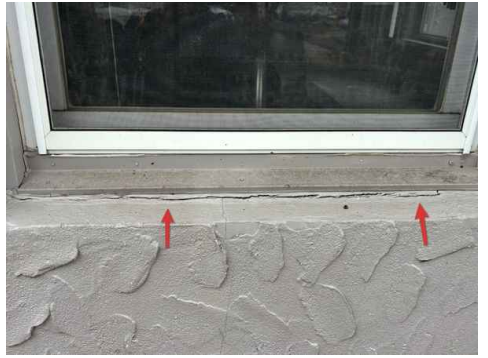
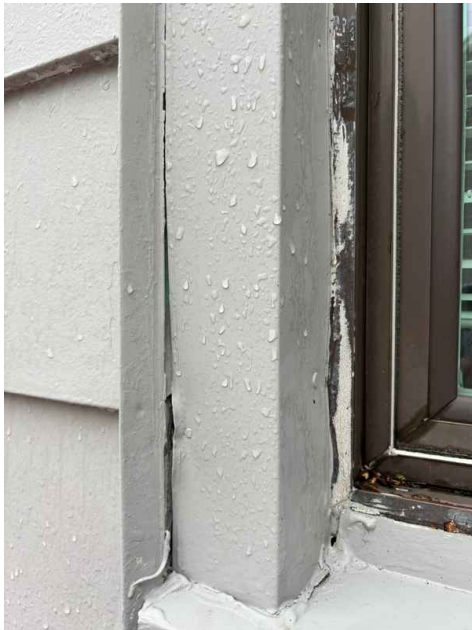
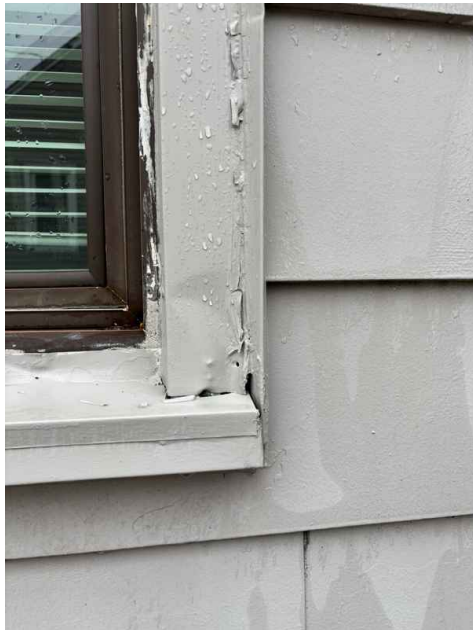
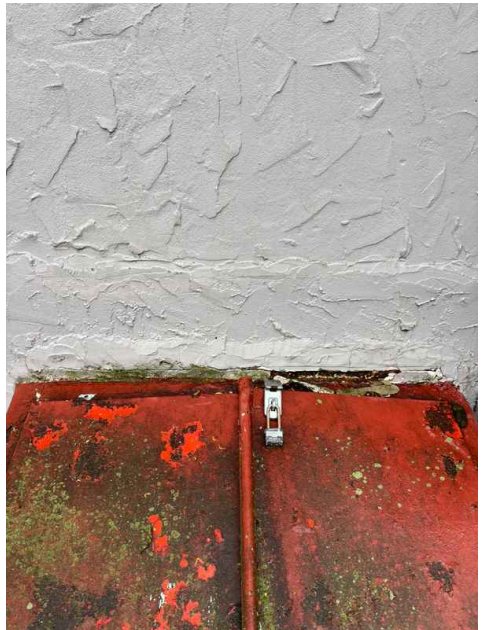
5.7.1 Sealant/Paint

***SEALANT - SUBSTANDARD**

Caulk/sealant was missing, deteriorated, substandard in more than one area. These areas may include but are not limited to: around windows and doors, at siding butt joints, at siding-trim junctions, at wall penetrations etc. Defective caulk/sealant can allow water to permeate into the wall structure resulting in damage. It is beyond the scope of the home inspection to determine if damage exists inside of the walls.

Recommend that a qualified contractor re-caulk as needed. If gaps are wider than 1/4 inch, an appropriate material other than caulk should be used.

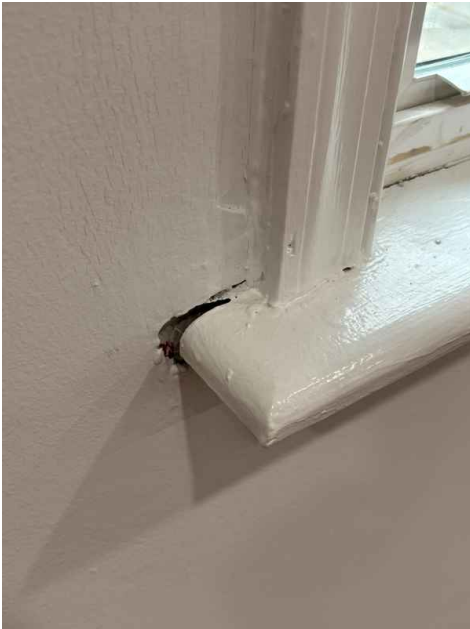
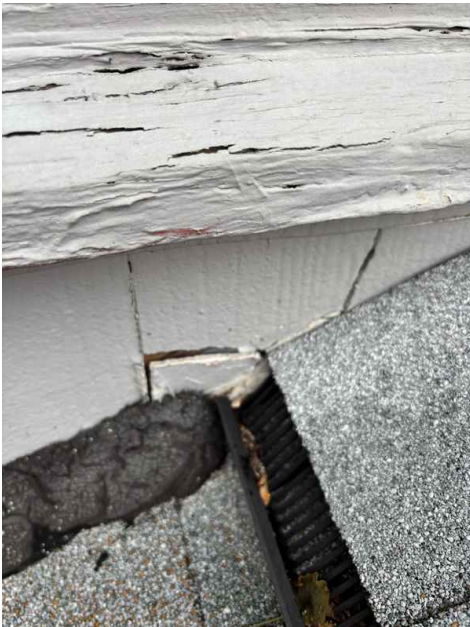
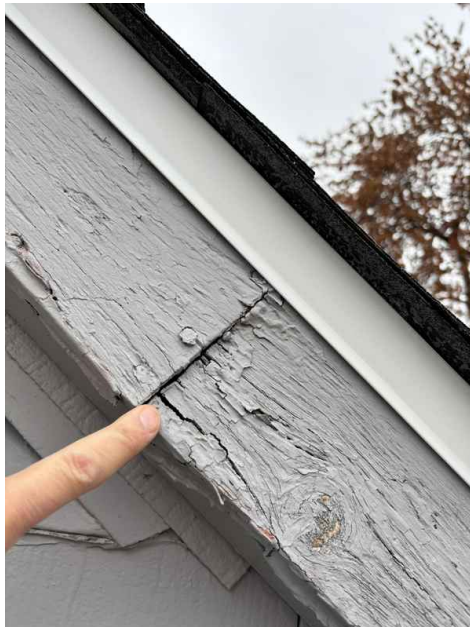
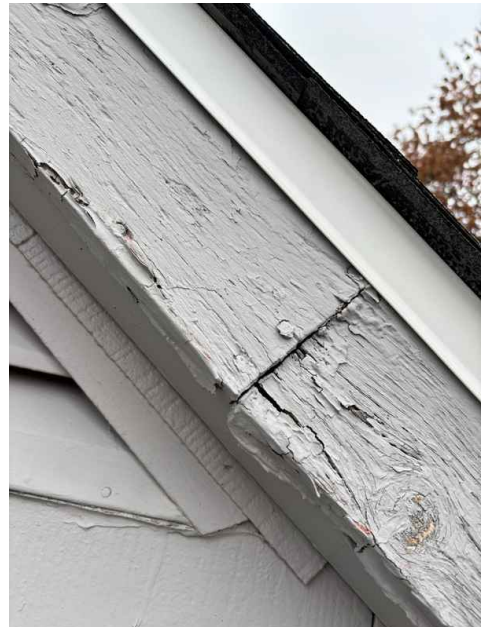
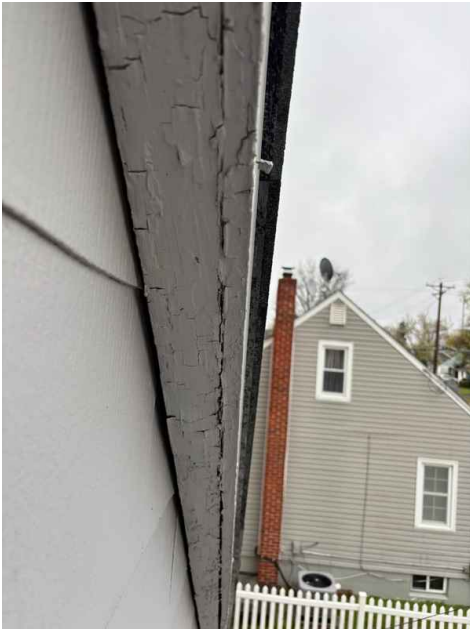
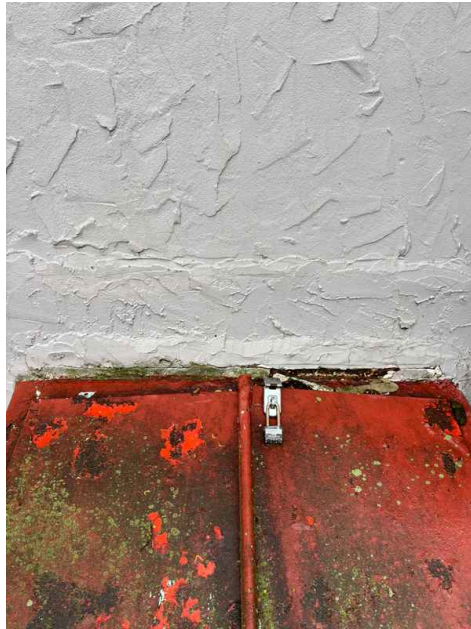
5.7.2 Sealant/Paint

***PAINTED/STAINED SURFACES DETERIORATED**

There was substandard exterior surfaces, including but not limited to siding, shutters, and/or trim that are peeling, faded, missing painted or stained areas. These substandard areas are prone to continued damage by ultraviolet light, wind and rain/moisture. Recommend having a qualified contractor evaluate, repair any damaged areas, prep, paint stain as needed.

Contact a qualified painting contractor.

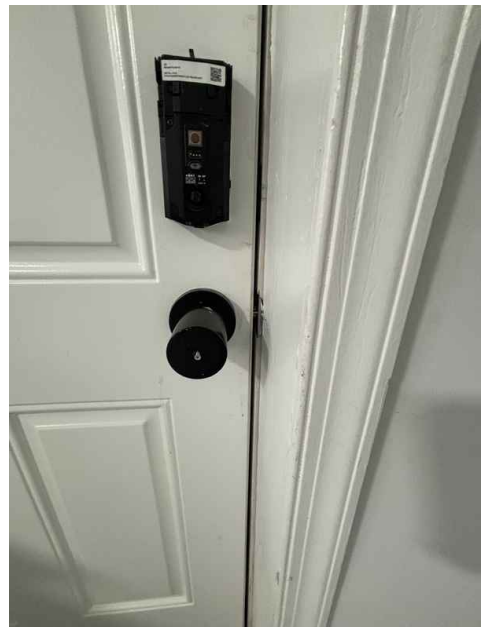
5.8.1 Exterior Doors

ELECTRONIC LOCK - COVER

EXCL - There was an electronic lock that was missing the cover. The lock could not be tested and is excluded from the home inspection. If the client intends to use this lock recommend having a qualified professional evaluate, repair or replace as needed.

Contact a qualified professional.

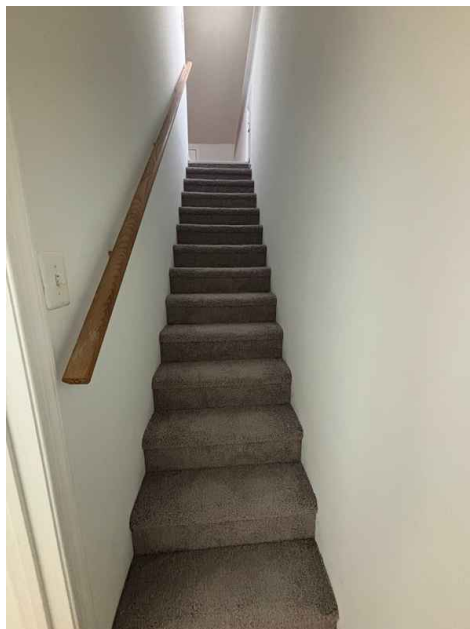
6.7.1 Stairs, Steps, Handrails, Guardrails

***HANDRAIL - NO RETURNS**

SFTY - The handrails did not have "returns". Current safety standards recommend for the handrails to "return" to the wall, so that clothing, etc. won't be snagged by a handrails end. Recommend having a qualified contractor evaluate and repair or replace to meet current building standards.

Contact a qualified professional.

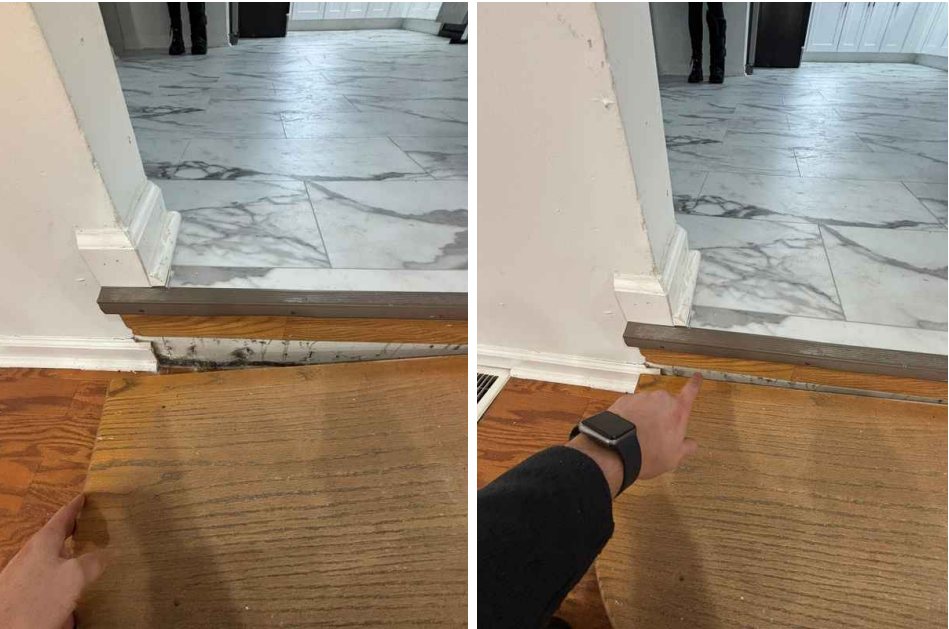
6.7.2 Stairs, Steps, Handrails, Guardrails

***TREADS - LOOSE**

SFTY - There were loose and/or damaged steps. This is a fall hazard. Recommend having a qualified contractor evaluate, repair or replace, as needed.

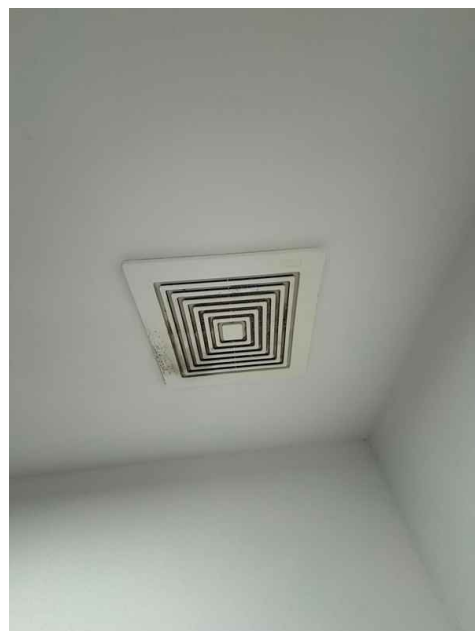
8.9.1 Ventilation

*VENTILATION FAN - INSUFFICIENT AIRFLOW

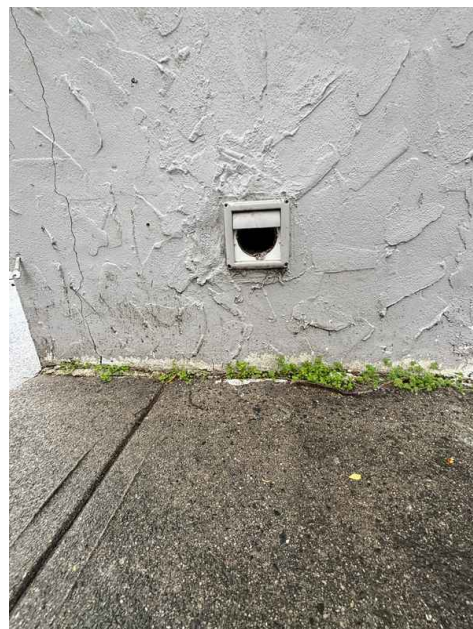
9.3.1 Dryer Vent

***COVER - MISSING/DAMAGED**

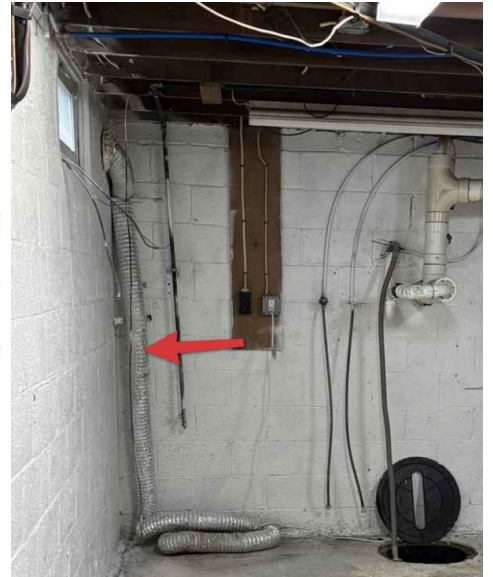
9.3.2 Dryer Vent

***DRYER VENT - WITHIN 5 FEET OF EXTERIOR HVAC UNIT**

Contact a qualified professional.

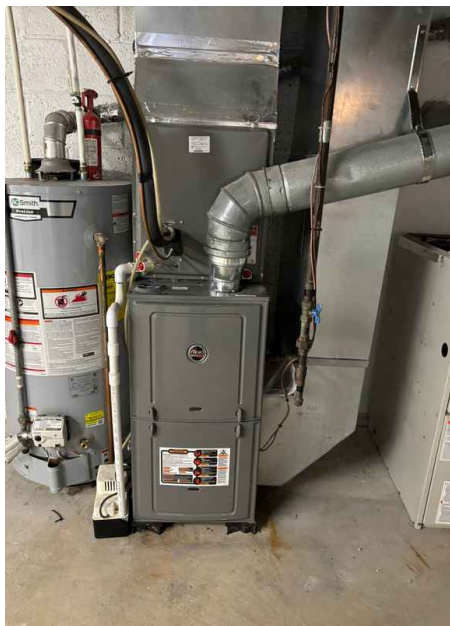
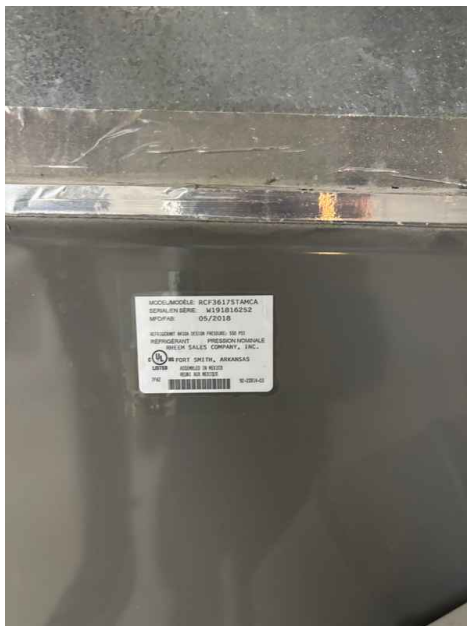
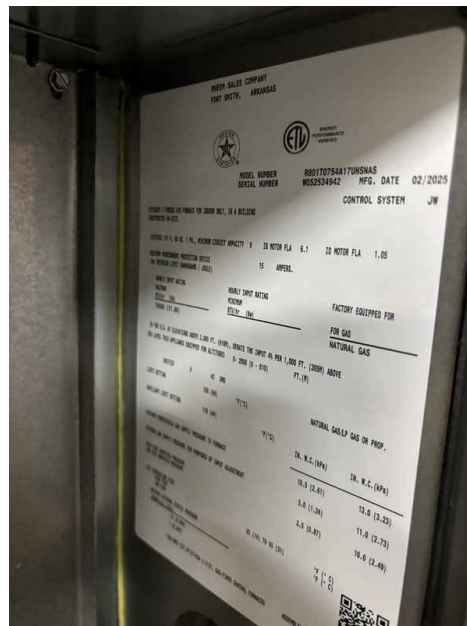
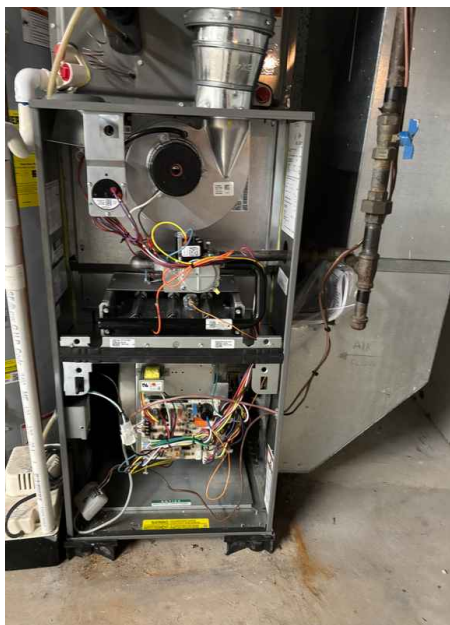
Interior Unit(s) - Split System : Interior HVAC Pictures

The interior unit(s) were inspected visually and tested by ensuring they responded to normal operating controls (at the thermostat), and that conditioned air was produced. The unit(s) responded to normal operating controls and no indications of deficiencies were observed at the time of inspection, unless otherwise noted in this report.

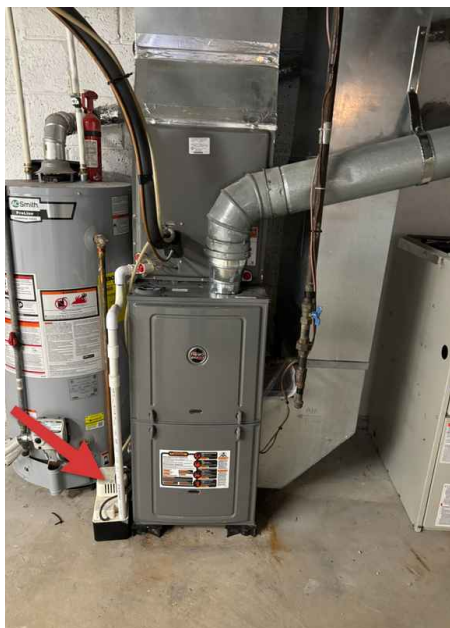
Condensate Drain Pipe: Condensate Pump Information

A condensate pump was being used to carry condensate from the interior unit's location to it's discharge point. Condensate pumps are not tested for functionality, as water would have to be poured into the unit to initiate a pump cycle. These units are inspected by looking for water or staining around the pump, which would indicate a failure of the unit. No deficiencies were observed at the time of inspection, unless otherwise noted in this report.

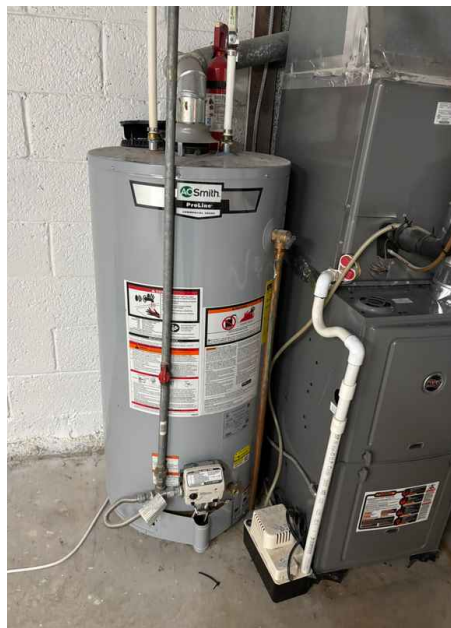
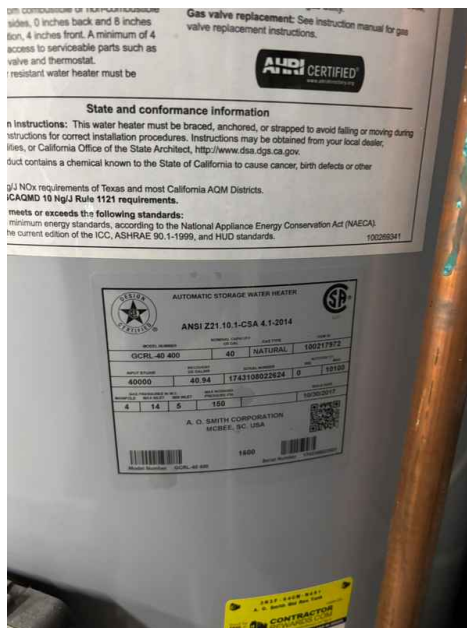
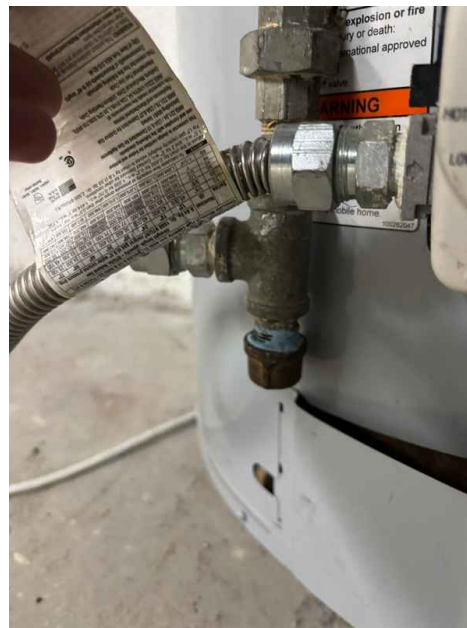
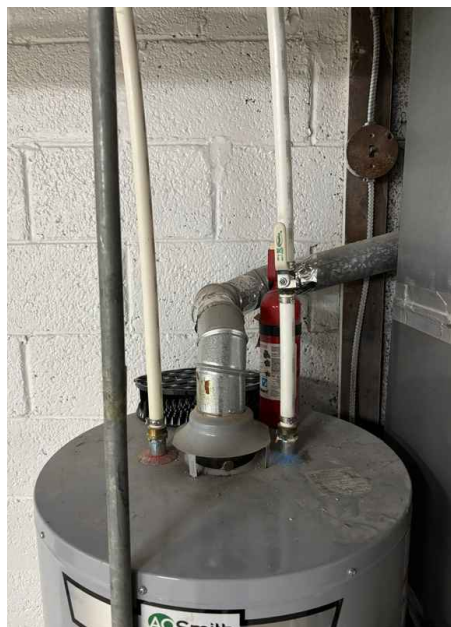
Gas, LP, Oil Fired Water Heater Condition: *Water Heater Pictures

The water heater was inspected by looking at the overall condition of the unit, its power source, the water pipes, etc., and that it produced hot water at the time of inspection. No reportable deficiencies were visibly present with the unit unless otherwise noted in this report.

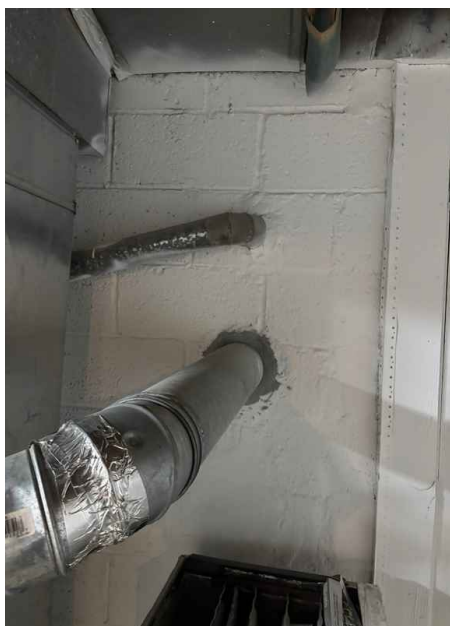
Venting: Venting Information

The vent was inspected at visible portions reporting on its material, its clearance from combustibles (if applicable), and its termination point. No indications of deficiencies were present unless otherwise noted in this report.

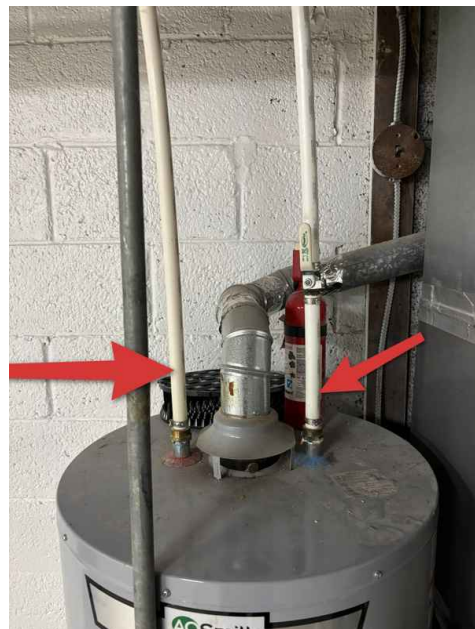
Water supply lines for gas fired water heaters are required to have adequate clearance from the hood and flue, typically 6 inches. This requires a minimum of 18 inches of copper pipe (often more) connected to the water heater then transitioning to plastic pipe. This is a fire hazard and should be corrected. Recommend having a licensed plumber replumb the water heater.

Contact a qualified professional.

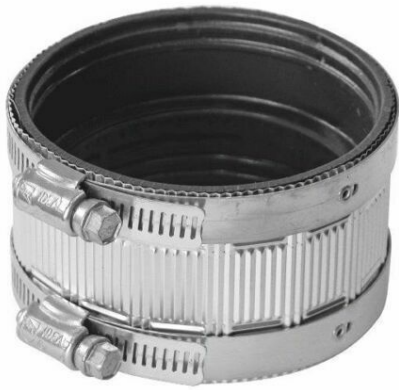
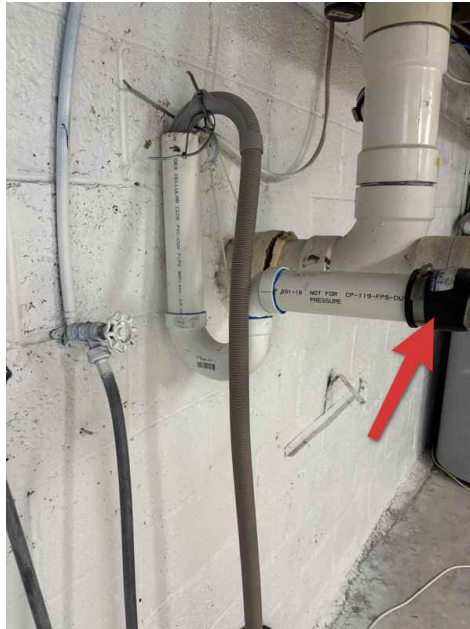
"Fernco fittings" Fernco is a brand name of a type of fitting commonly called a no hub band. If this type of fitting is used to connect DWV (Drain, Waste, Vent) pipes a reinforced band is required to prevent settling and lateral movement. One or more Fernco style fittings were found that were not reinforced. This can lead to failures and subsequent leaks. Recommend having a licensed plumber replace all substandard fittings.

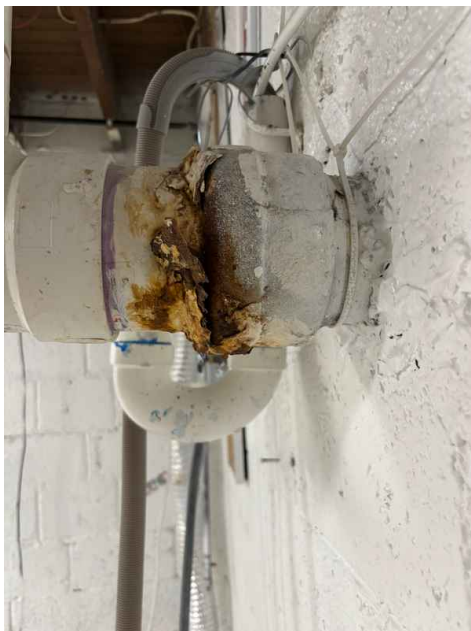
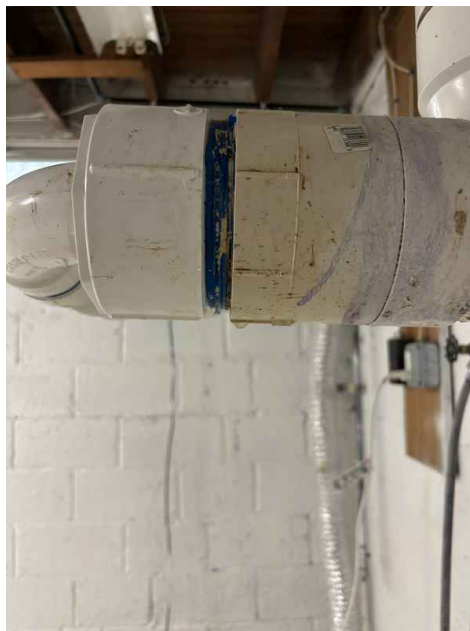
DETERIORATED/DEFECTIVE WASTE LINES

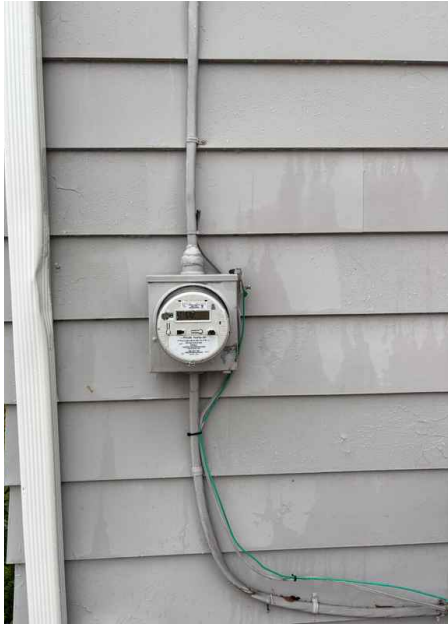
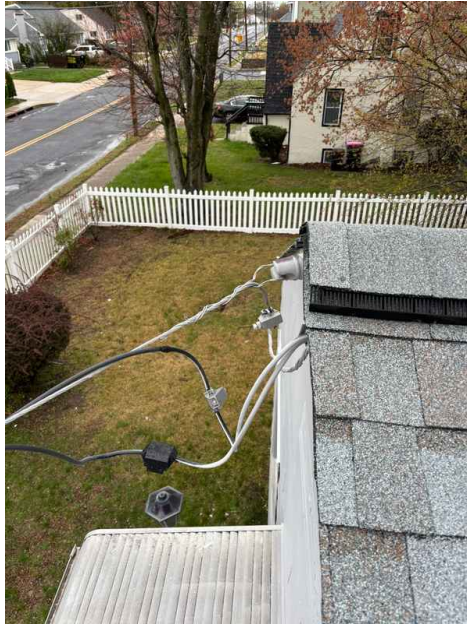
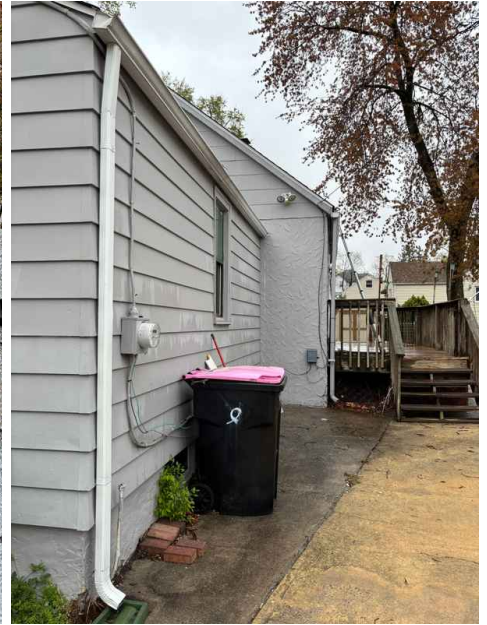
Service Entrance: SEC And Electric Meter Pictures

Power was supplied to the home via an overhead service drop. The meter and service entrance cable appeared to be in satisfactory condition. No deficiencies were observed at visible portions unless otherwise noted in this report.

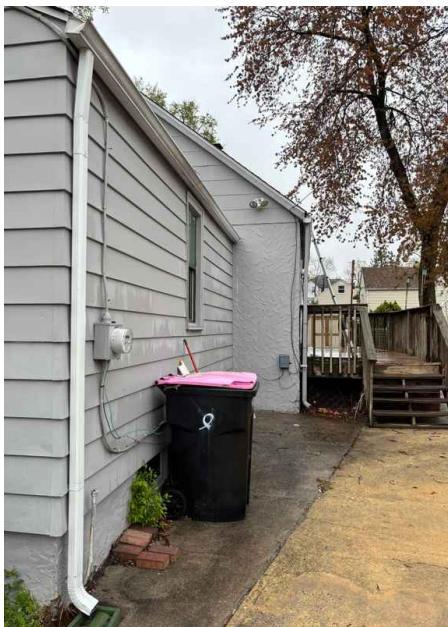
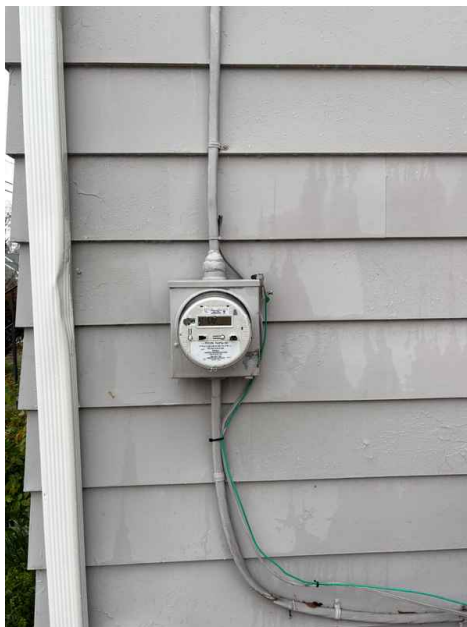
Service Entrance: *SEC ❖❖❖ Painted

LMT - The service entrance cable and or components were painted. This is a limitation on the inspection. Damage or defects may exist that were not readily visible at the time of the inspection.
