RESIDENTIAL INSPECTION

04/11/2025

Joshua Shellenberger

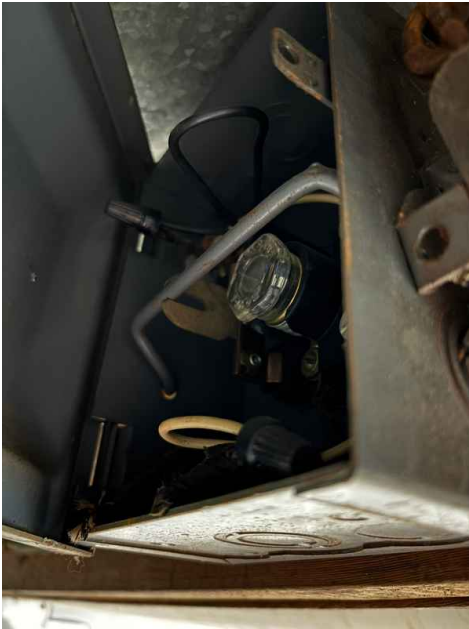
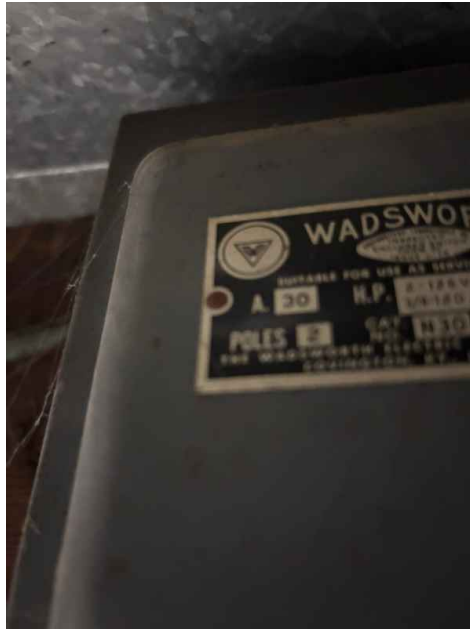
The subpanel was an old Wadsworth panel which is outdated. The subpanel utilized glass screw base fuses, these are also an outdated technology and can be dangerous because oversized fuses may be installed. The inspector did not have full visual access and could not determine if grounding and bonding were correct. Recommend having a licensed electrician evaluate and repair/replace as needed.

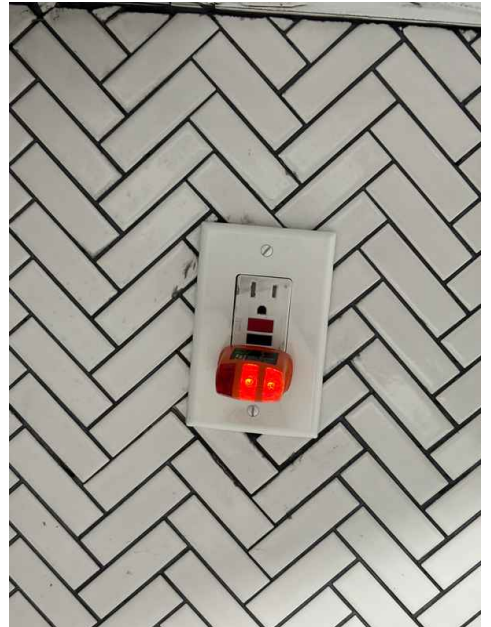
13.10.2 GFCI Protection

***GFCI - WOULD NOT RESET**

One or more GFCI receptacles were tripped testing for proper operation or were tripped prior to the inspector testing them and would not reset, leaving it inoperable. This is indicative of a defective GFCI outlet or that a ground fault exists on that circuit. Recommend having a licensed electrician evaluate and repair/replace as needed.

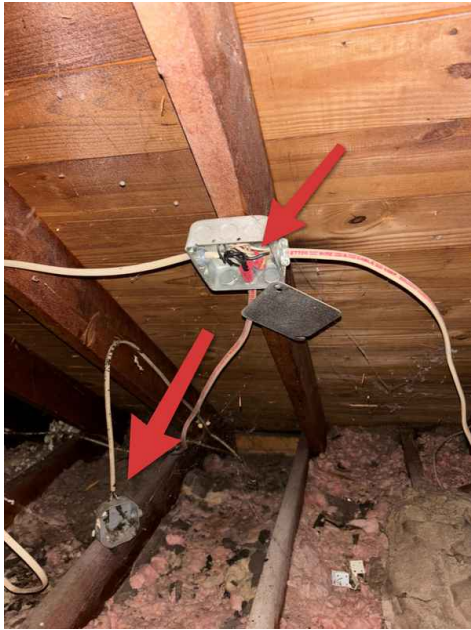
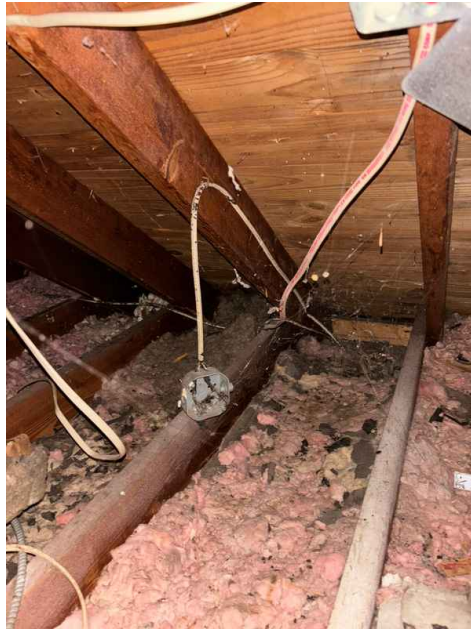
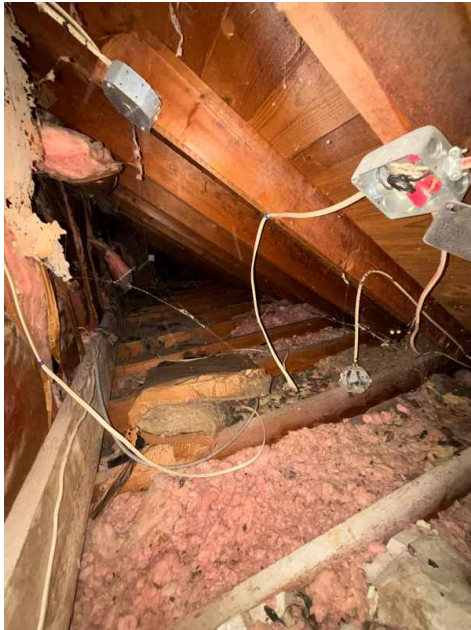
There were one or more cover plates for switches, receptacles, lights or junction boxes that were loose, missing, broken, missing screws, wrong cover for the application or substandard. These plates are intended to contain fire and prevent electric shock from occurring due to exposed wires and terminals, and to seal out the weather when applicable. Recommend having a licensed electrician install cover plates where necessary.

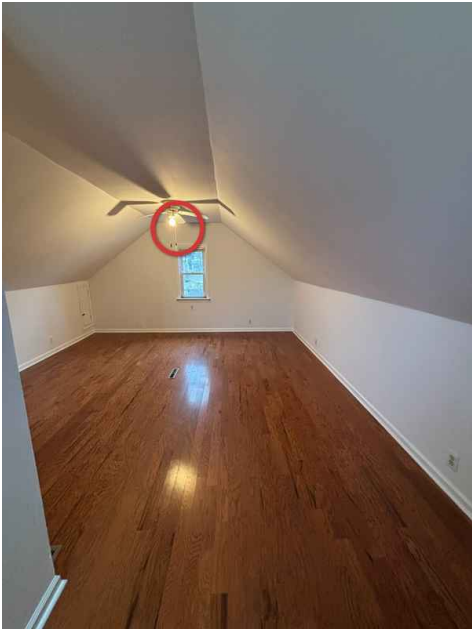
13.12.1 Ceiling Fans

FAN LIGHT - GLOBE(S) MISSING

The globe or globes were missing on the ceiling fan. Recommend having a qualified person install a globe.

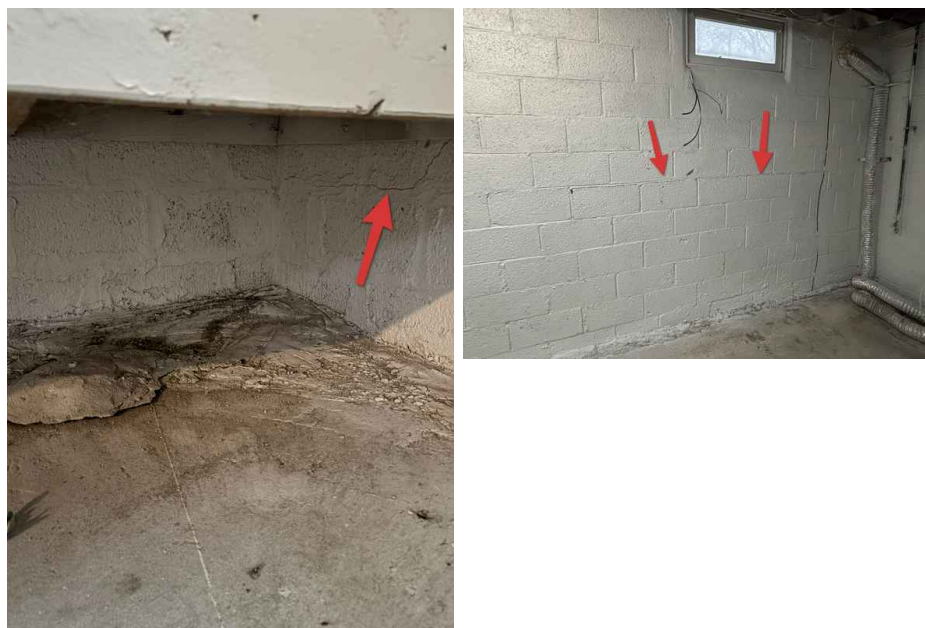
Foundation Walls: Foundation Wall Crack(s)

Most areas obscured by recent paint coating. , Minor cracks no evidence of water permeation from the cracks and no visible displacement of the foundation.

Any references to cracks on foundation walls below grade will need to be sealed at a minimum by a qualified person to prevent the possibility of moisture/water infiltration, regardless of the cracks size.

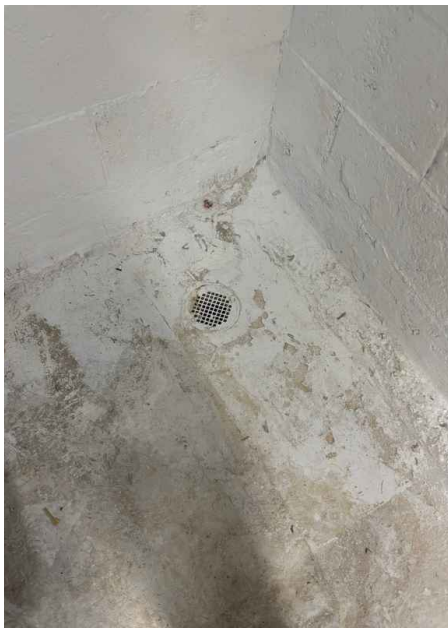
Floor/Slab Condition: Floor Drain(s) Present

Floor drain(s) were present in the basement. Floor drains are present for one reason only, and that is to drain water. The presence of these drains may be an indication that water is or has infiltrated into this area. I recommend consulting with the seller as to water infiltration and monitoring the area during rainfall events with the understanding that future repairs may be needed. The functionality of the drain(s) was not tested for and is excluded from this inspection.

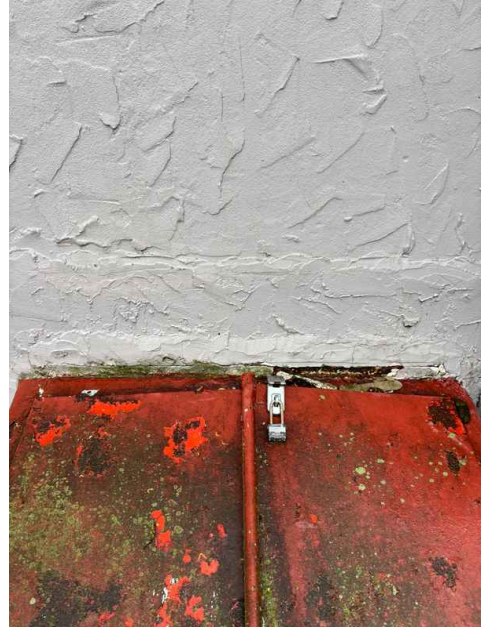
***BILCO DOOR - RUST**

The Bilco door was rusted. Recommend having a qualified contractor evaluate and repair or replace as needed.

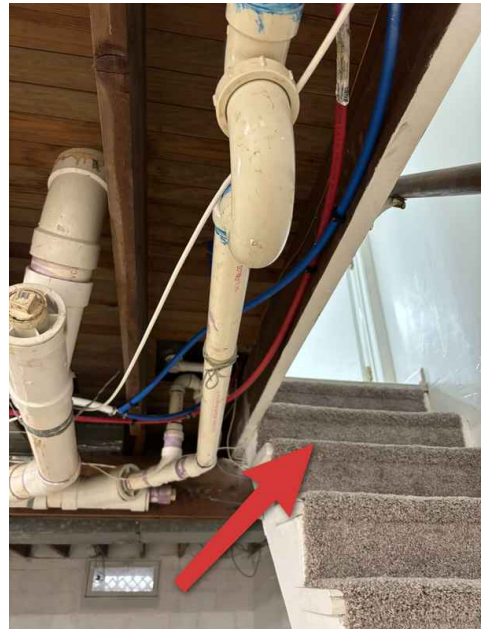
14.3.1 Stairs, Steps, Handrails, Guardrails

***HANDRAIL - OPEN**

SFTY - Balusters or other appropriate guards were missing from the handrail system that would prevent a person from falling through the railing. Recommend having a qualified contractor modify or replace the railing to meet these safety standards.

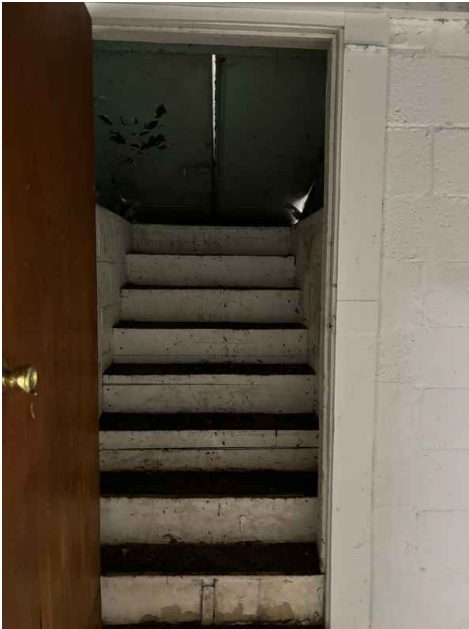
14.3.2 Stairs, Steps, Handrails, Guardrails

***HANDRAIL - MISSING >3 STEPS**

SFTY - Handrails and balusters at one or more flights of stairs were missing. This is a potential fall hazard. Handrails are required to be installed on all steps/stairs that have over three risers. Handrails must be 34 to 38 inches above the nose of the tread. Recommend having a qualified contractor install handrails where missing and per standard building practices.

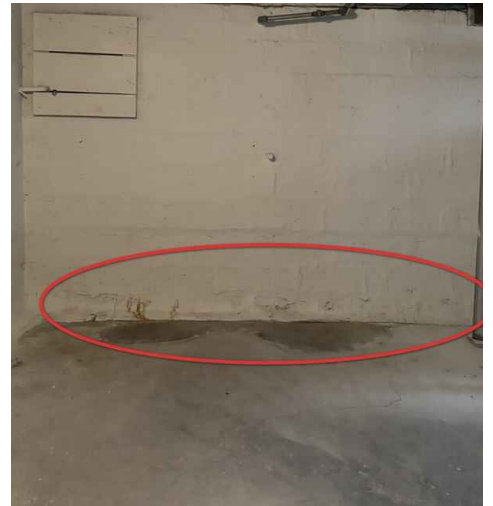
14.4.1 Moisture Presence

*MOISTURE - INDICATIONS OF PAST/PRESENT MOISTURE

Contact a foundation contractor.

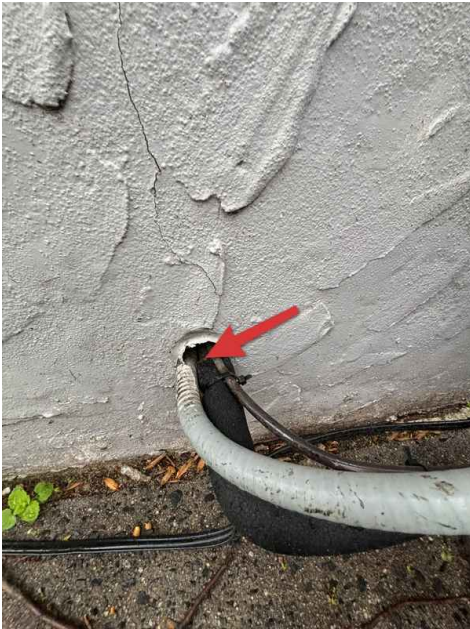
14.5.1 Foundation Walls

*FOUNDATION WALL(S) - GAPS/OPENINGS

Contact a qualified professional.

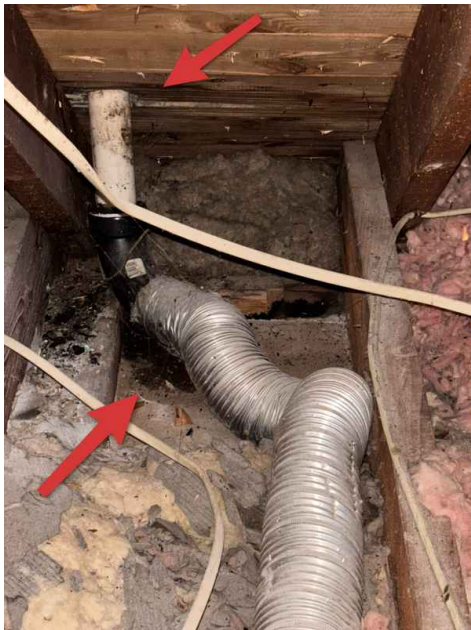
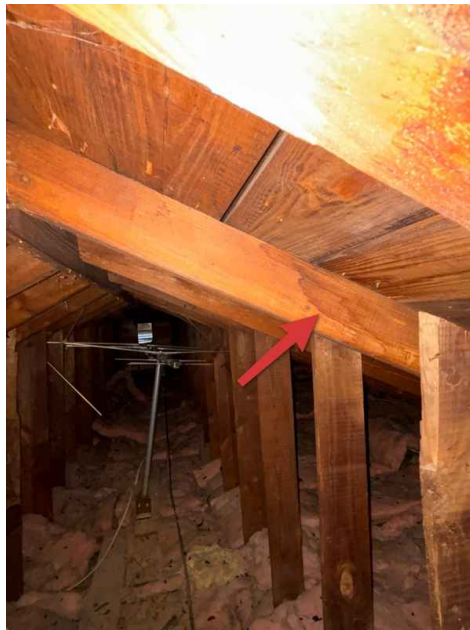
15.2.1 Attic Access

*LITTLE OR NO ACCESSIBLE ATTIC SPACE

Contact a qualified roofing professional.

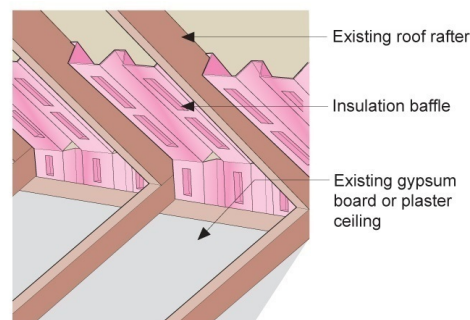
15.6.1 Ventilation

SOFFIT VENTS - BLOCKED BY INSULATION

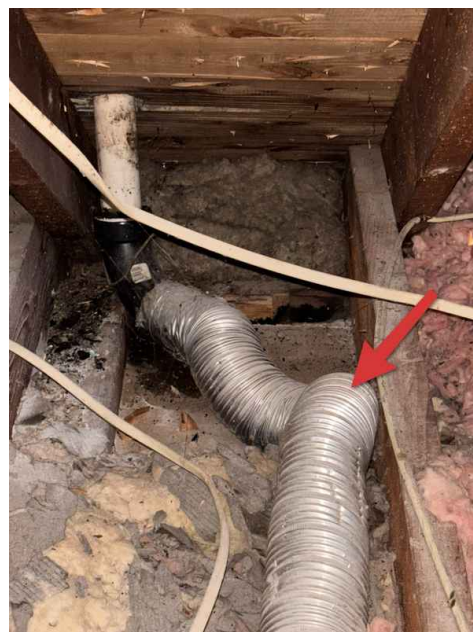
15.7.1 Exhaust Fan(s)

*EXHAUST DUCTS NOT INSULATED

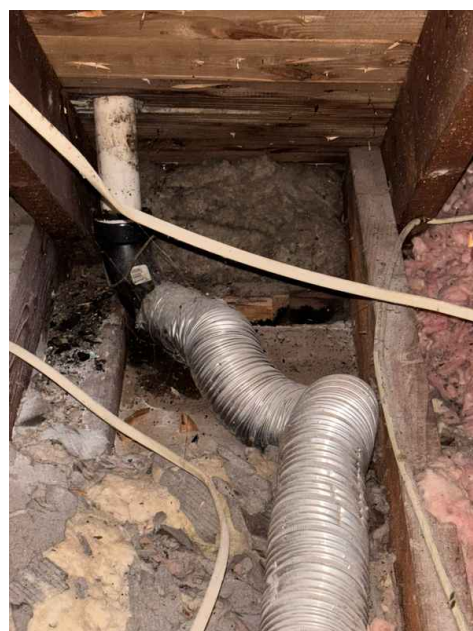
15.7.2 Exhaust Fan(s)

EXHAUST DUCT - SUBSTANDARD
